**Historical Land Use Investigation of
6700-04 West Fairview Avenue
Milwaukee, Wisconsin**

File: 405-24

March 14, 2011

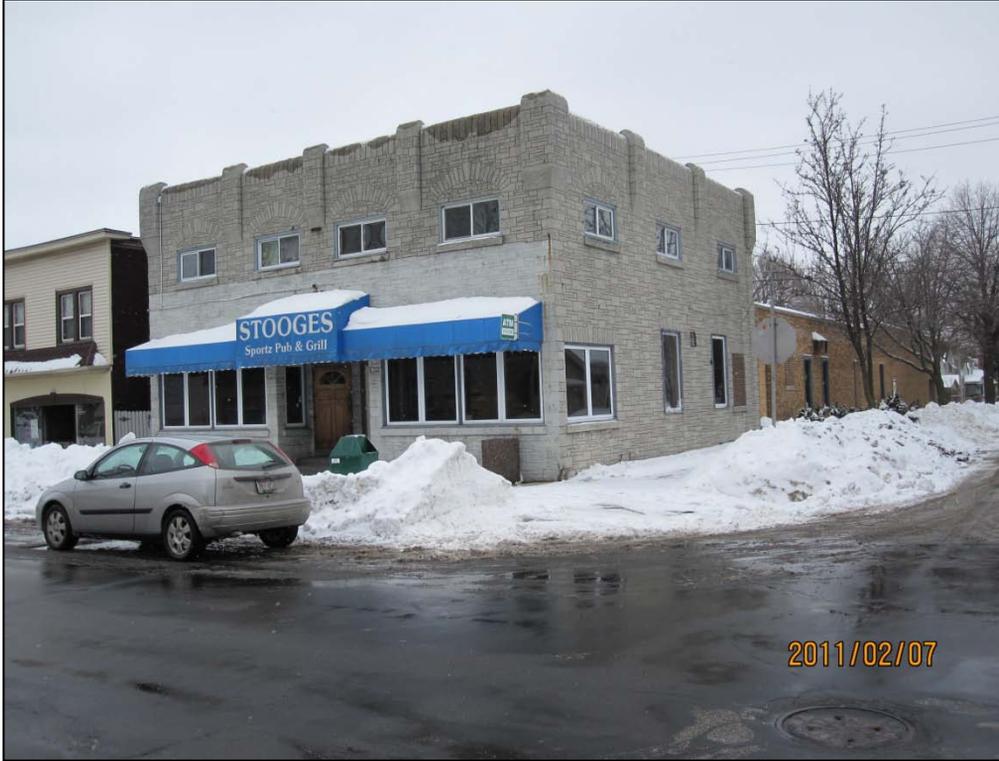
Photo 1: View of Project Site facing northwest from 67th and Fairview Avenue

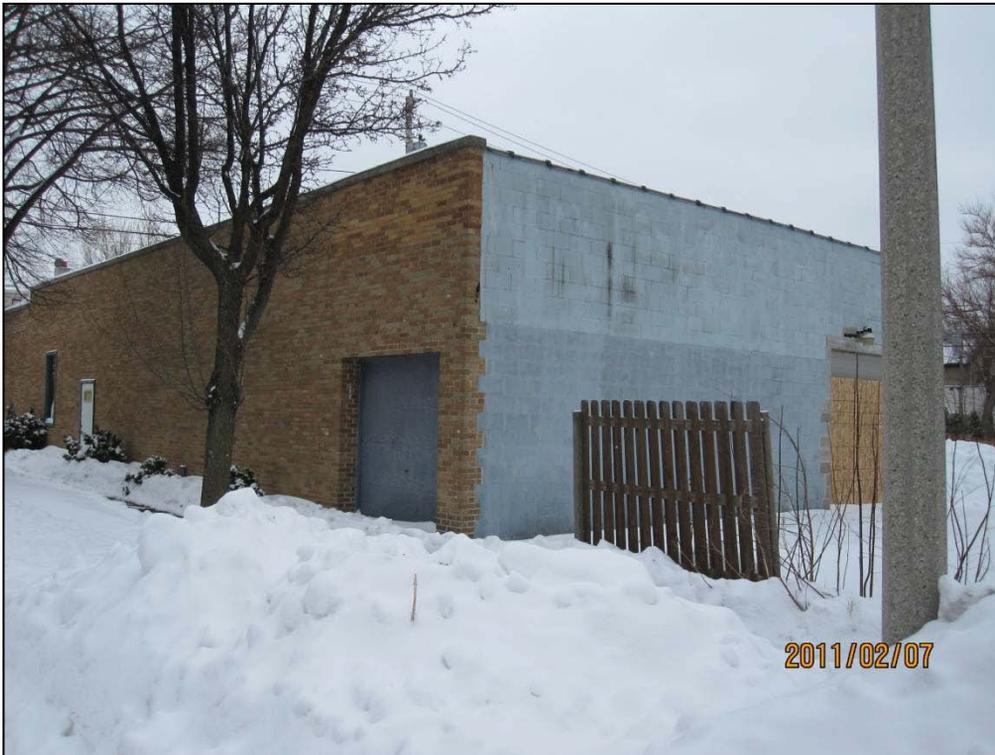
Photo 2: View of Project Site rear facing southwest from 67th and Stevenson Avenue

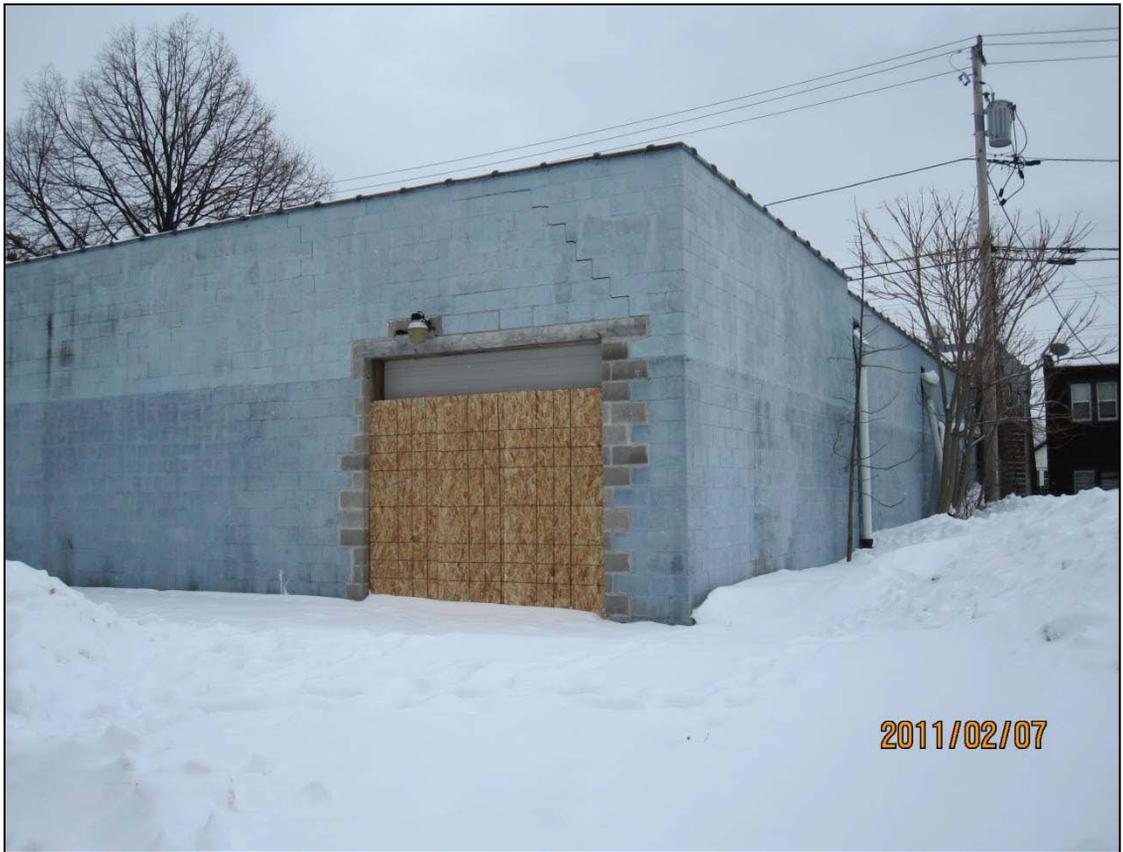
Photo 3: View of Project Site rear facing southeast from Stevenson Avenue

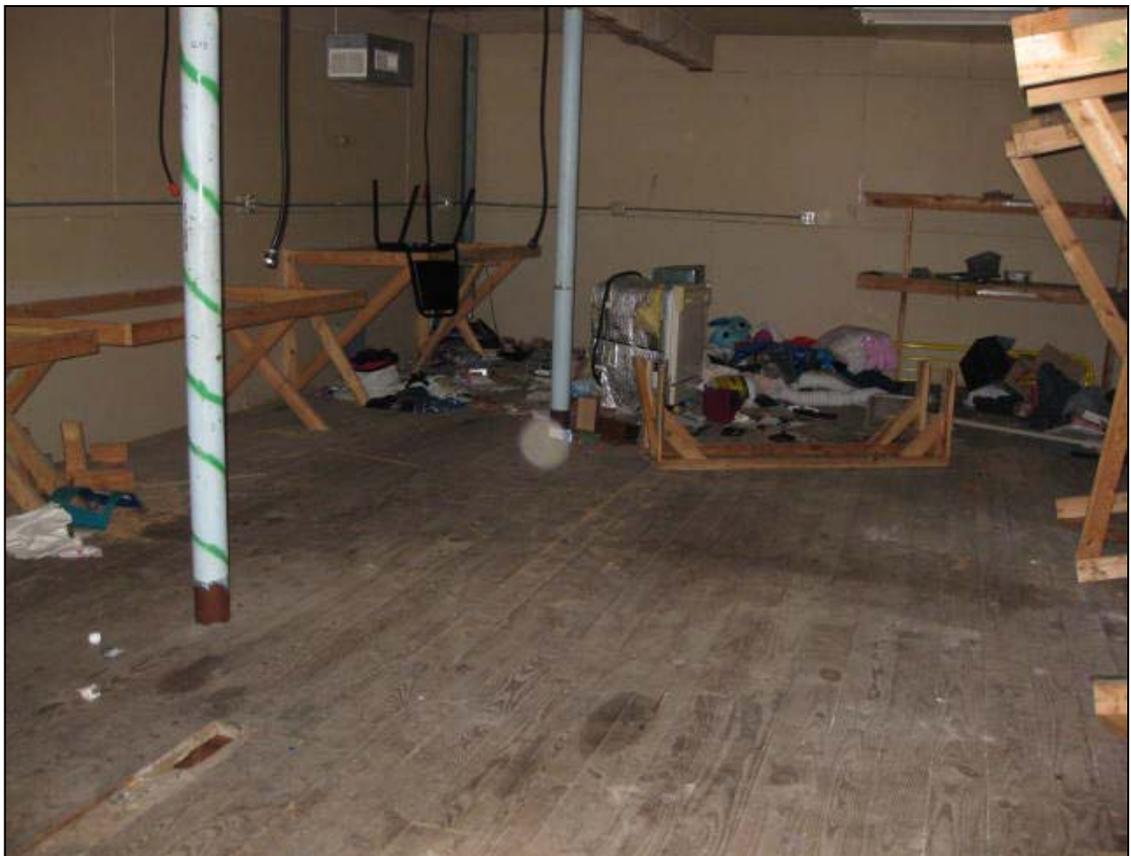
Inspection of the 1st floor interior revealed conditions typical to a tavern and restaurant including bar, kitchen area, tables and arcade games. To the rear of the main rooms was a storage room separated into two areas. One storage area had unfinished floors with exposed insulation that appeared to be typical fiberglass material (Photos 4 & 5). The two rooms connected at the rear near the garage doors and a cinder block ledge approximately 2-feet tall (Photo 6). The storage rooms were sparsely occupied with furniture, construction materials and other general debris such as clothing, household appliances, and garbage.

Photo 4: View of 1st Floor rear storage room general conditions

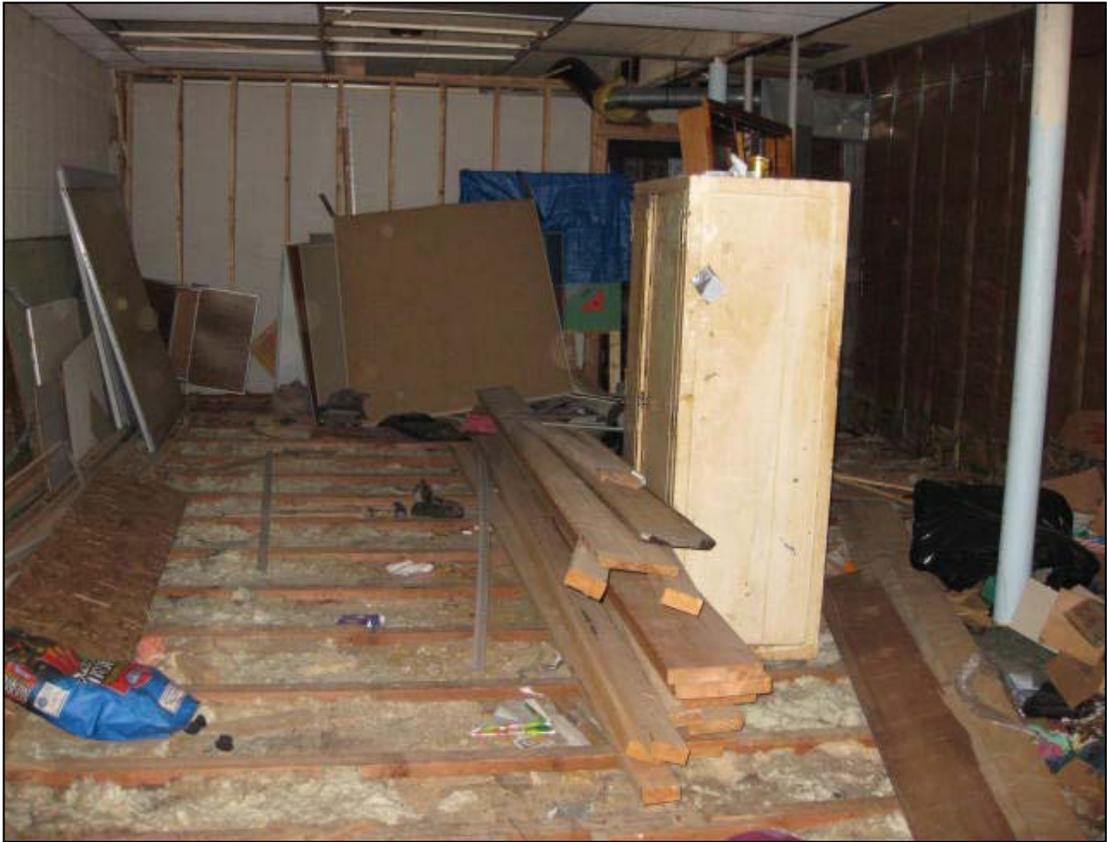
Photo 5: First floor rear storage room general conditions

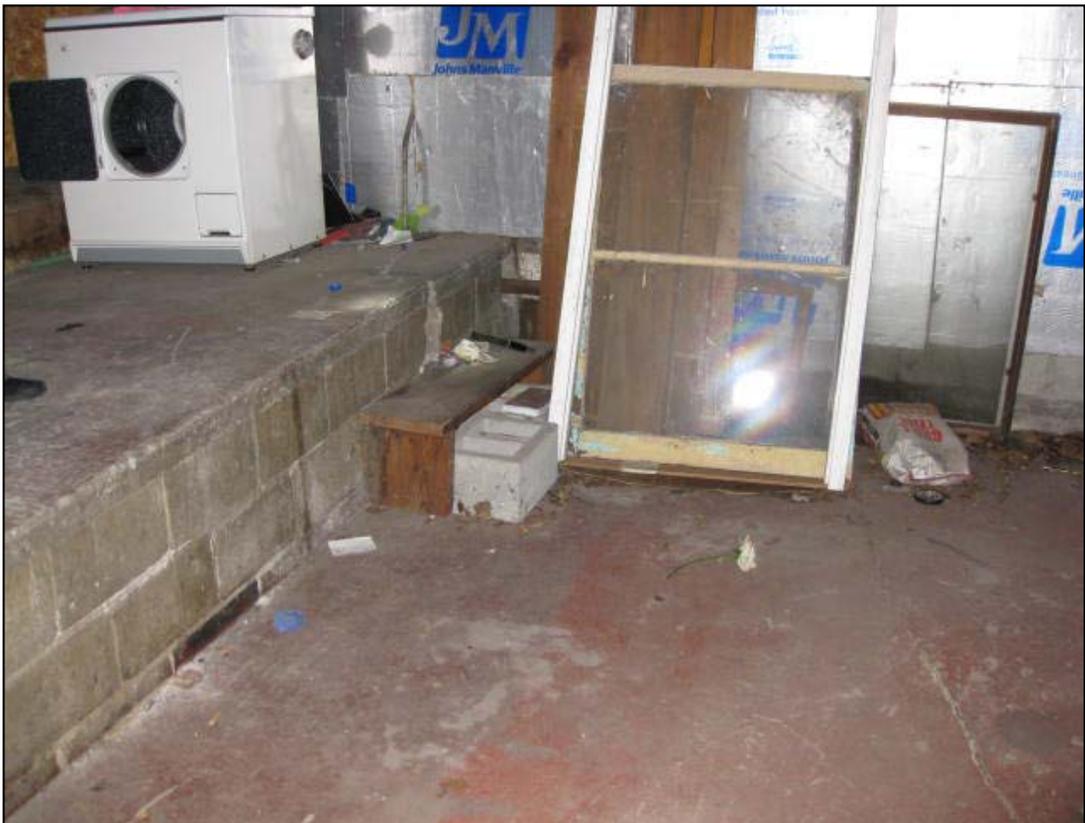
Photo 6: First floor storage area near rear garage door

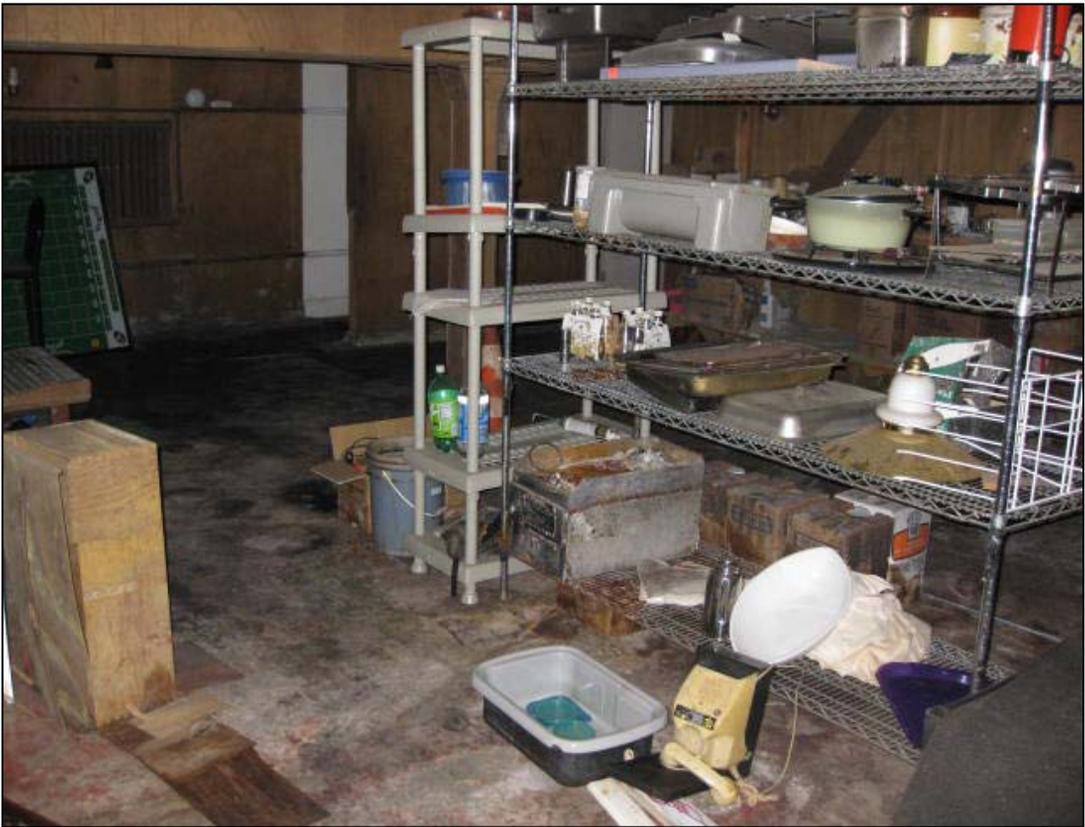
Photo 7: Basement storage area near bottom of stairs

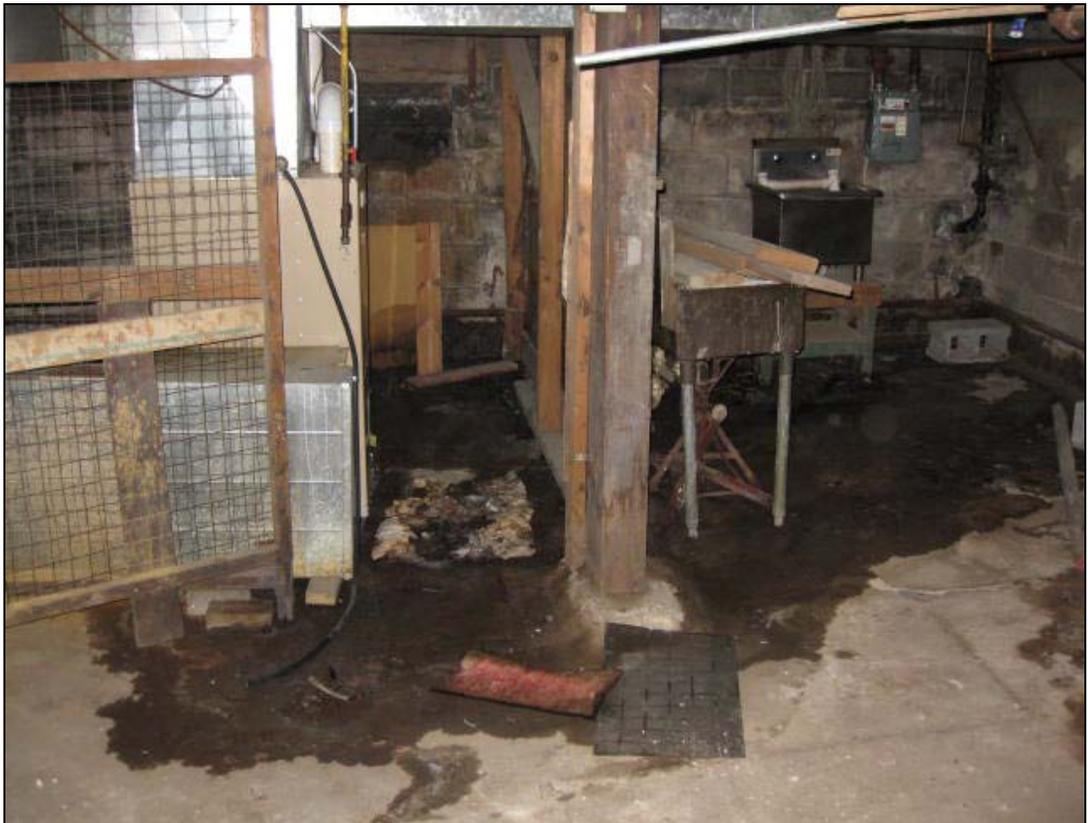
Photo 8: Basement utility room with standing water and drain

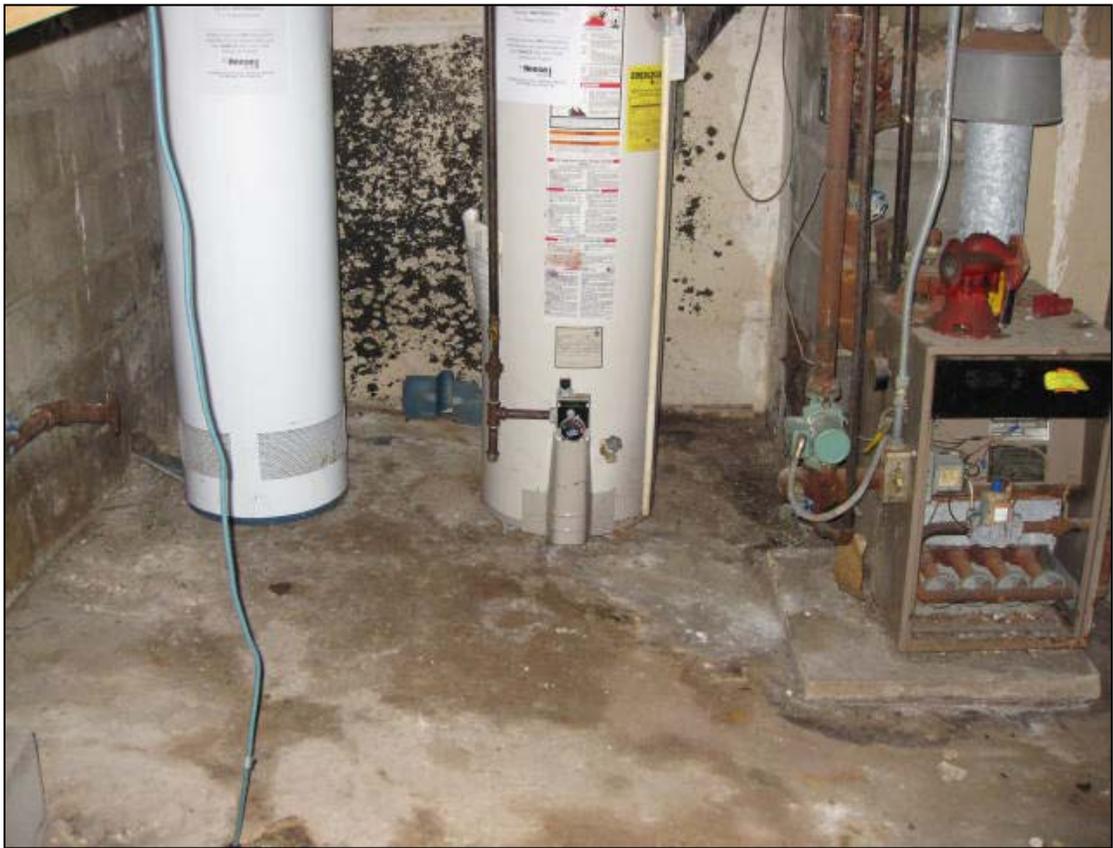
Photo 9: Gas water heaters and furnace in basement utility room

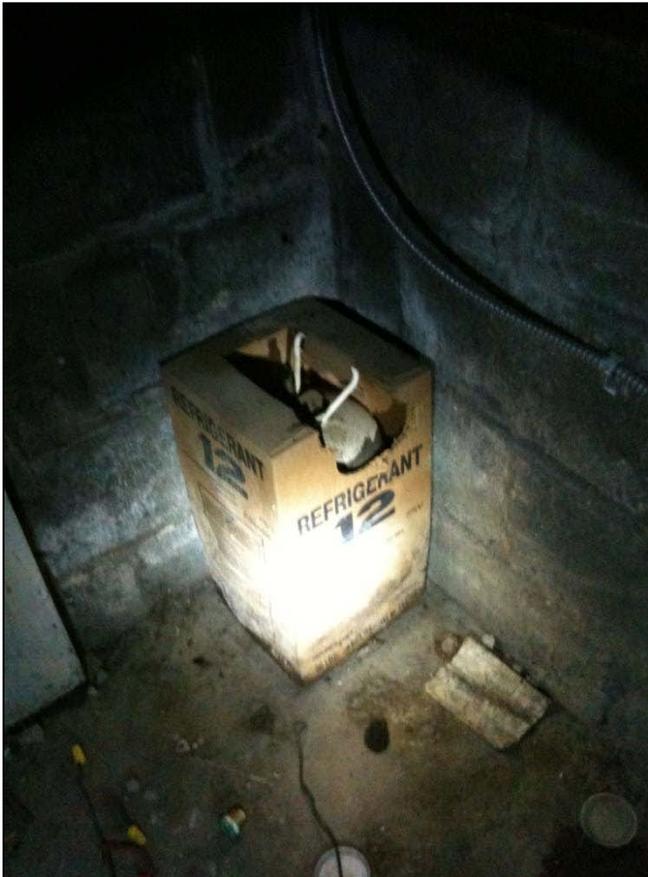
The basement of the project site includes several rooms occupied by equipment and supplies typical to a tavern and restaurant such as food handling and cooking equipment, cases of wine and liqueur, beer kegs, soft drink canisters, beverage pumping equipment, pressurized carbon dioxide cylinders, coolers and related materials (Photo 7). Standing water was identified in a utility room but appears to be due to rainwater infiltrating through the foundation (Photo 8). Several gas fired furnaces and water heaters were identified within the basement and first floor of the project site (Photo 9). City staff identified pressurized canisters of "Refrigerant 12" which appears to be used for maintenance of the coolers (Photo 10). One small area of the basement floor was damaged and exposed under the concrete slab (Photo 11).

Photo 10: Refrigerant 12 stored in basement corner

This Historic Land Use Investigation did not reveal environmental concerns warranting a Phase II Environmental Site Assessment. However, it is recommended that refrigerants be disposed or recycled properly.

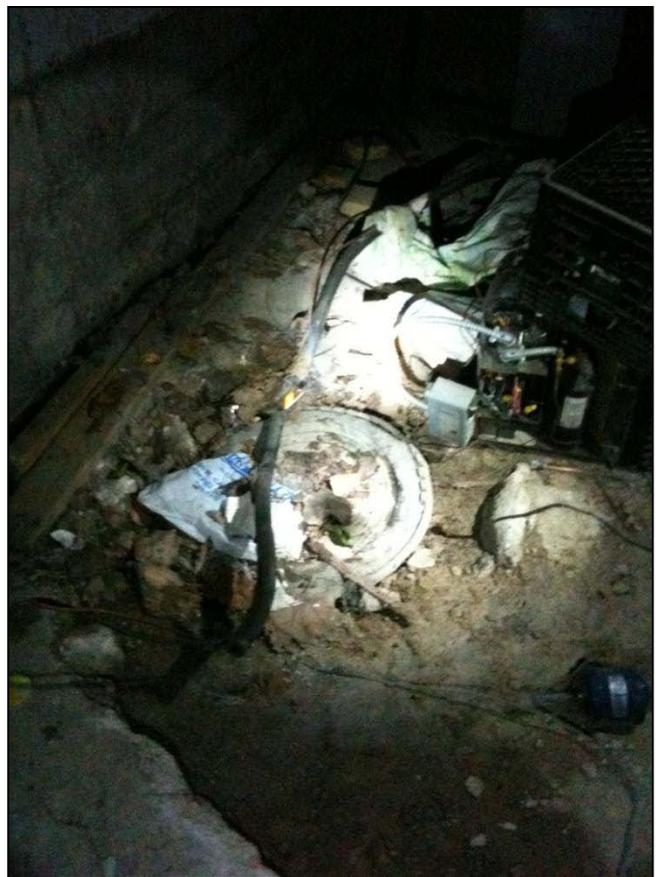
Photo 11: Damaged concrete basement floor
