**Engineering Evaluation of the  
Estabrook Park Dam on the  
Milwaukee River  
Milwaukee, Wisconsin**

Milwaukee County  
Department of Public Works

STS Project No. 5-87996

September 8, 2006

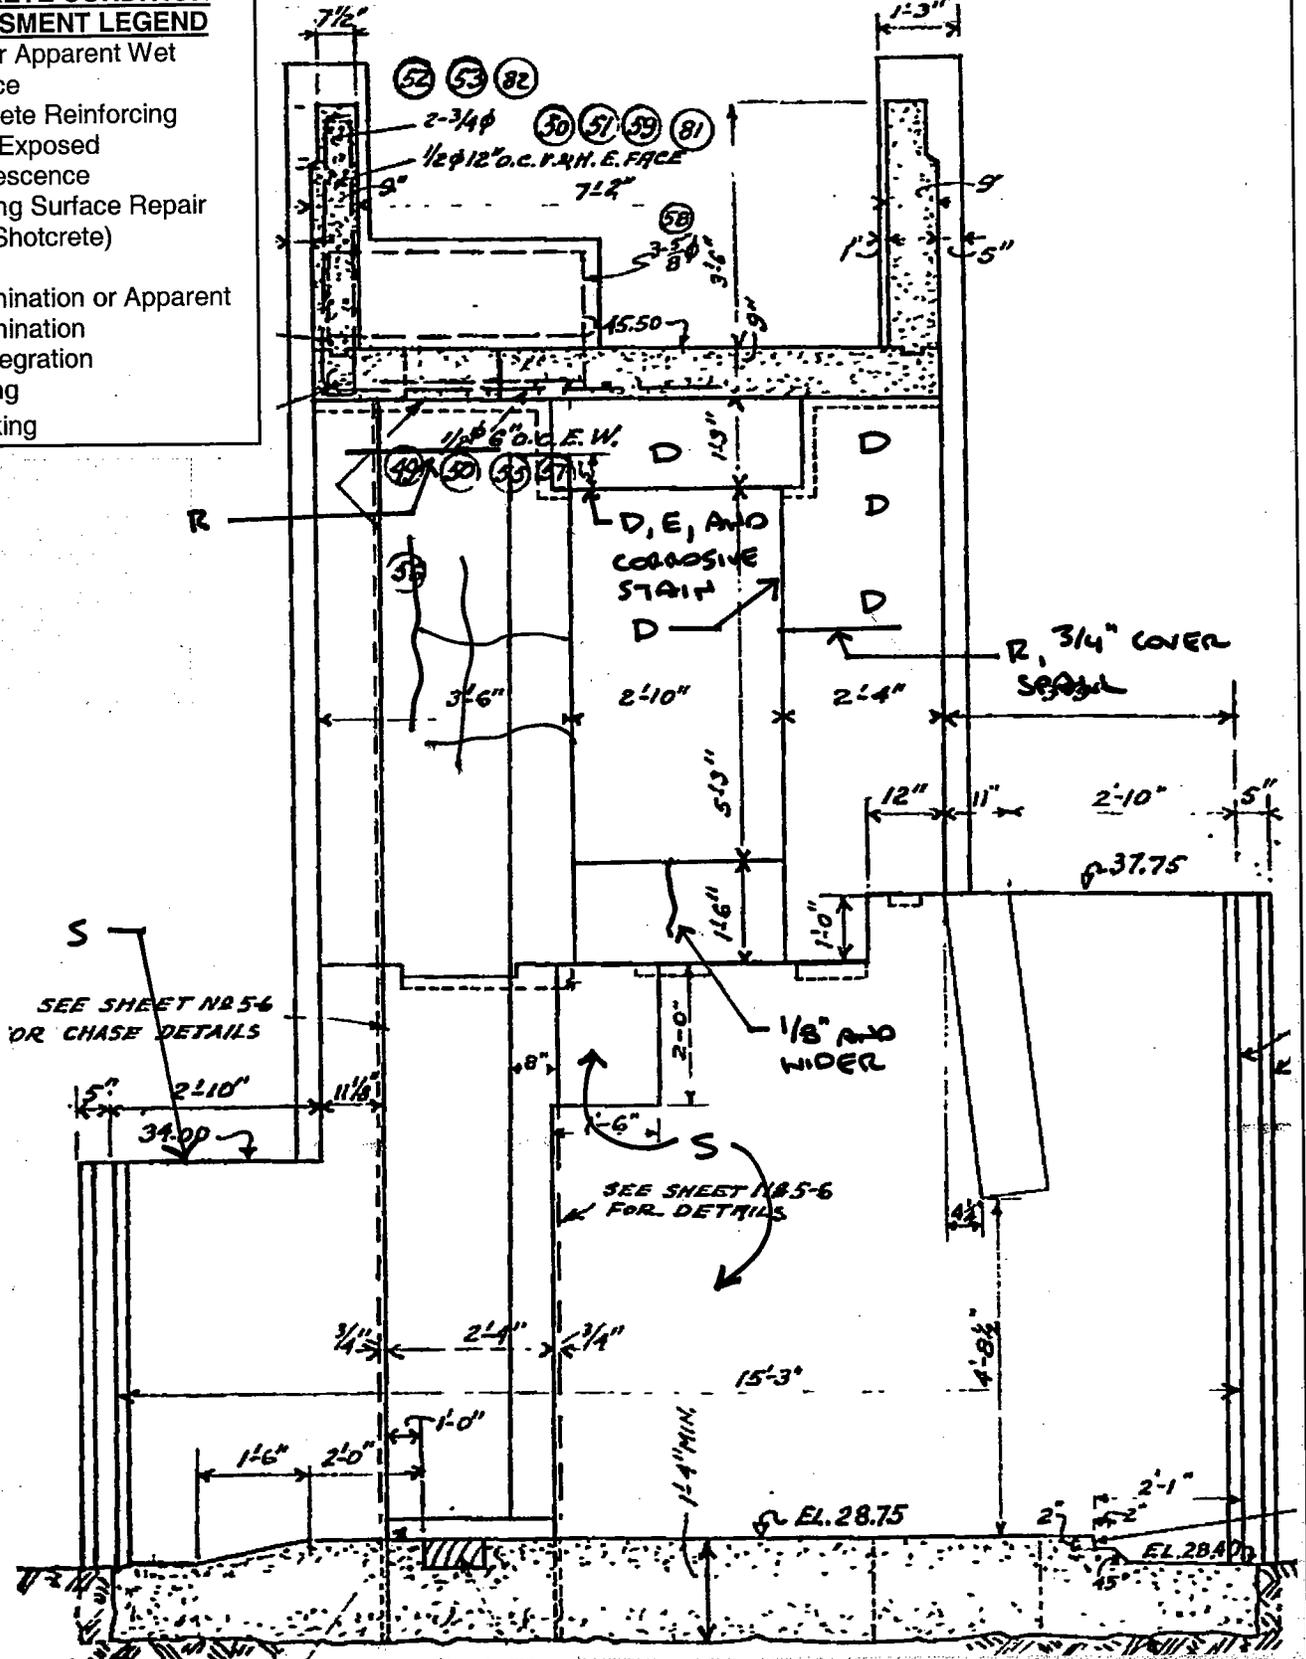
FIGURE 4

Piers between the abutments appeared in overall fair (above elevation 37.75') to poor condition (below elevation 37.75'). Refer to Figures 1 through 24 in Appendix C for additional condition assessment observations, specifically with respect to left and right pier conditions. Common conditions observed by STS include widespread surface repair below elevation 37.75', delaminations, spalls, and cracks. Based on acoustic impact testing performed on pier numbers 1 and 11, it appears that the majority of pier surface covered with surface repair material (e.g. gunite) is delaminated. Multiple piers exhibited areas where former gunite repairs were either partially or fully delaminating from the substrate.

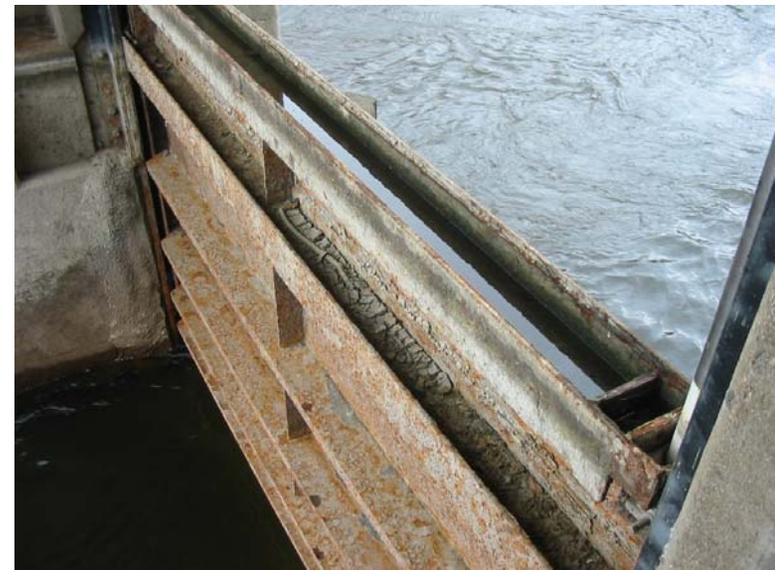
Photograph 4 – View of typical slide gate. Note surface rust and water ponding in top channel. Drill drain holes to allow water to drain and sandblast and paint gates.

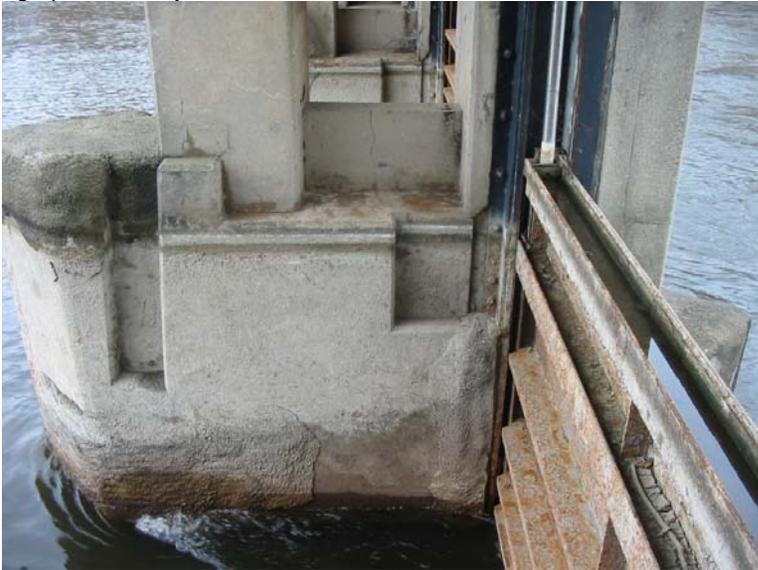
Photograph 5 – Right side of pier 10. Note gunite on pier surface

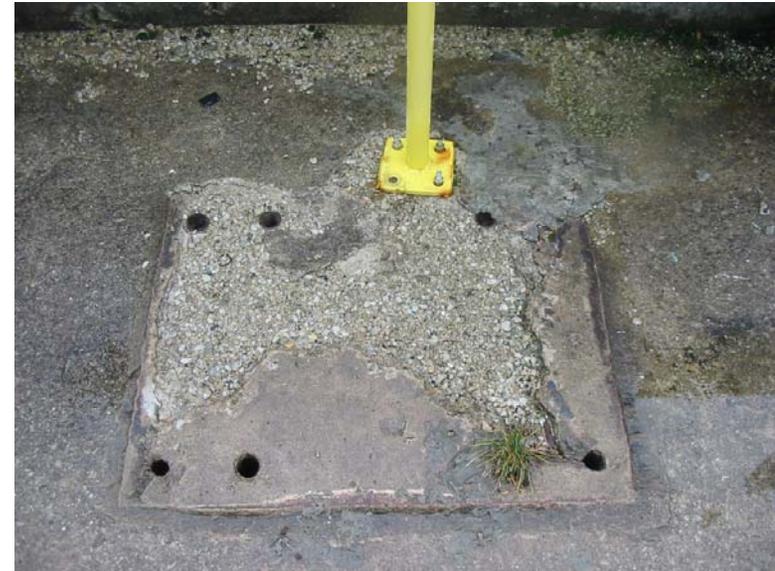
Photograph 6 – View of typical concrete surface deterioration on spillway operating bridge deck

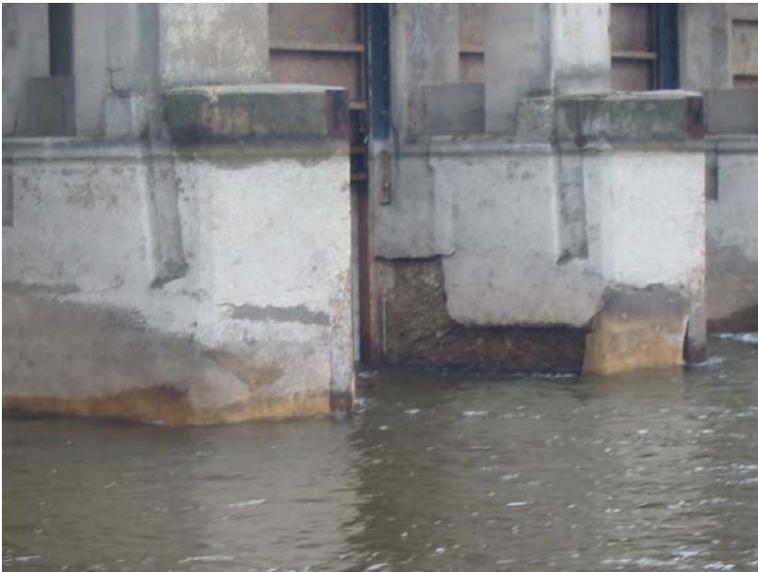
Photograph 7 – View of typical area of spalling of gunite overlay on lower part of spillway piers

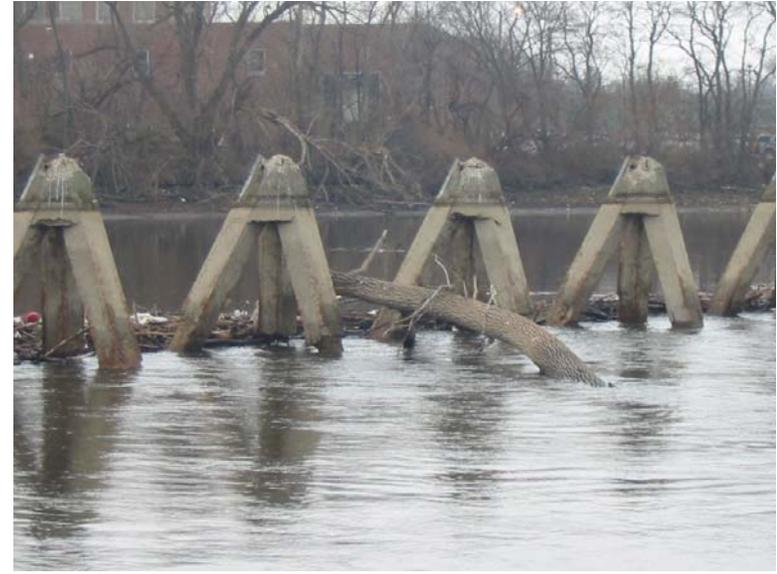
Photograph 10 – View of ice breakers. Note deterioration of concrete at tops and accumulation of woody debris.

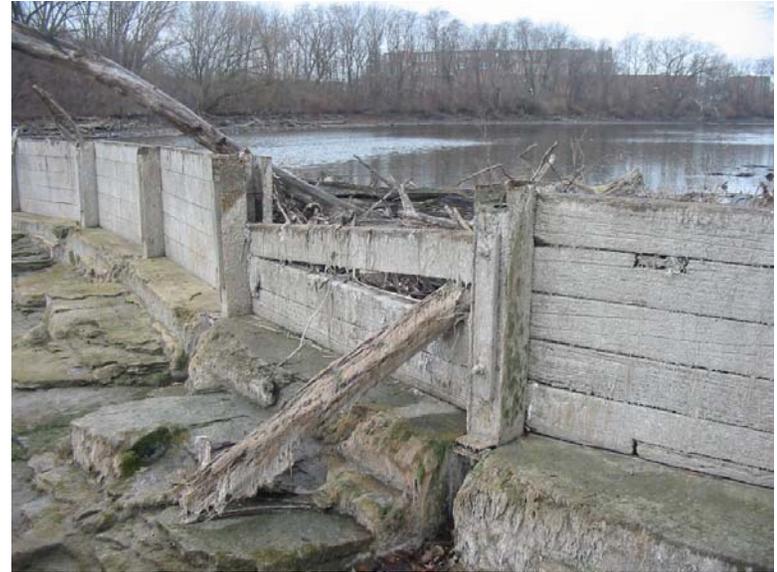
Several of the flashboards are missing or cracked. The flanges of the flashboard supports are bent at several locations.

Photograph 18 – View of flashboards. Note missing boards and penetration by debris. Also note bent flashboard support to the left

- The overflow spillway flashboards should be replaced and the bent supports repaired. Surface repair of deteriorated concrete on the overflow weir crest should be performed.
- The gated spillway section was found to be stable for overturning and sliding under normal pool conditions. Under full pool conditions with ice loading, the section was found to be unstable. We, therefore, recommend the current operation practice of drawing down the impoundment during the winter months be continued and that the ice breakers be maintained to prevent impact to the gated spillway by large debris or ice rafts.
- The ice breakers do not require an extensive rebuild, only repair of deterioration at the tops.
- The large accumulation of woody debris upstream of the overflow spillway section should be removed. We recommend that the County study measures to facilitate periodic debris removal.

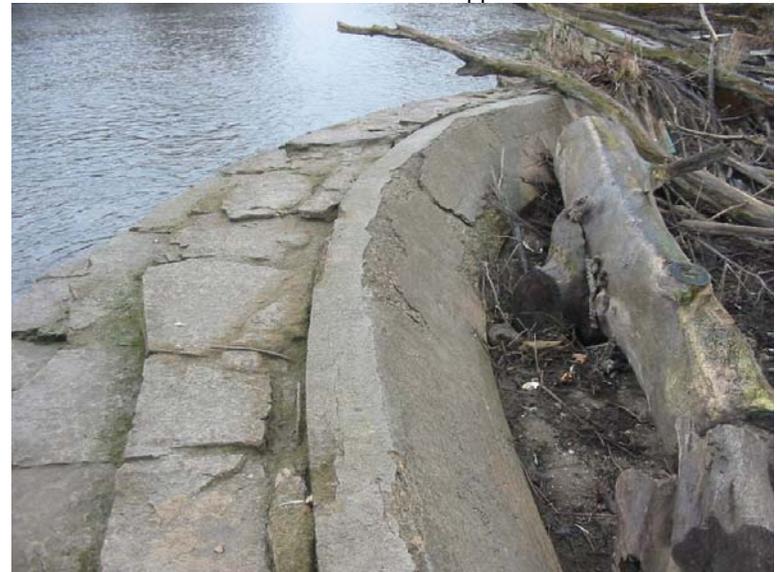
Photograph 20 – View of typical area of concrete deterioration on the weir crest of overflow spillway. Note horizontal rebar anchor exposed on top of rubble masonry.
