Certificate of Appropriateness

101 E. KILBOURN AV.

PTS ID 37285 COA, rebuild, restore Kilbourn bridge over the Milwaukee river

CERTIFICATE OF APPROPRIATEMENTS APPLICATION FORM ATTACHMENT A
KILBOURN AVENUE BASCULE BRIDGE
Kilbourn Avenue at the Milwaukee River

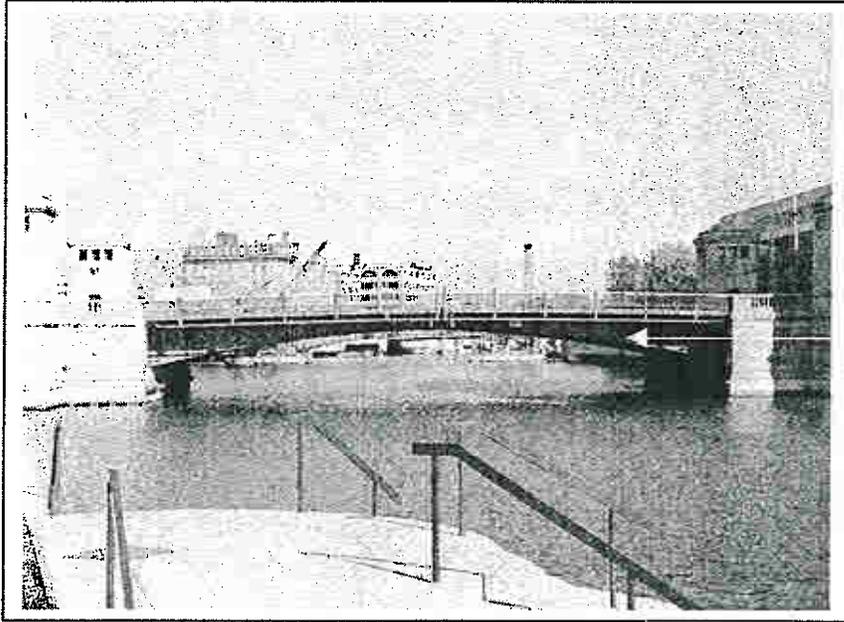
Photo #1 Bridge Span looking South

Structural steel,
except girders, to be
removed and replaced

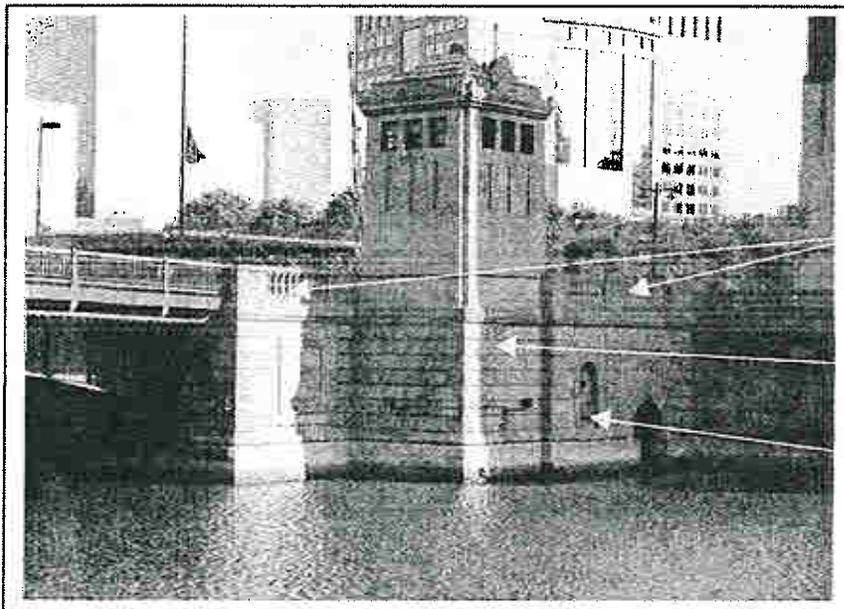
Photo #2 Southeast Pier

Sections of damaged
existing balustrade to
be repaired or replaced

Damaged limestone to
be repaired or replaced

Pier doors to be
replaced with doors to
match original type

Care should be taken to replace any damaged stone on the bridge houses with matching new stone that is carefully finished to the specifications of the original stones. Most of the stones are called "ashlars" and are characterized by a subtle grooving of their surfaces, which elegantly catches the light and cast small shadows on the face of the stone. Replacement of the stone balusters should be held to a minimum.

Any new mortar used to repair the bridge houses should match the original in terms of color, texture and hardness. Research has shown that when new mortar that is too hard is installed in an old wall, that premature failure of the new mortar is likely to occur.

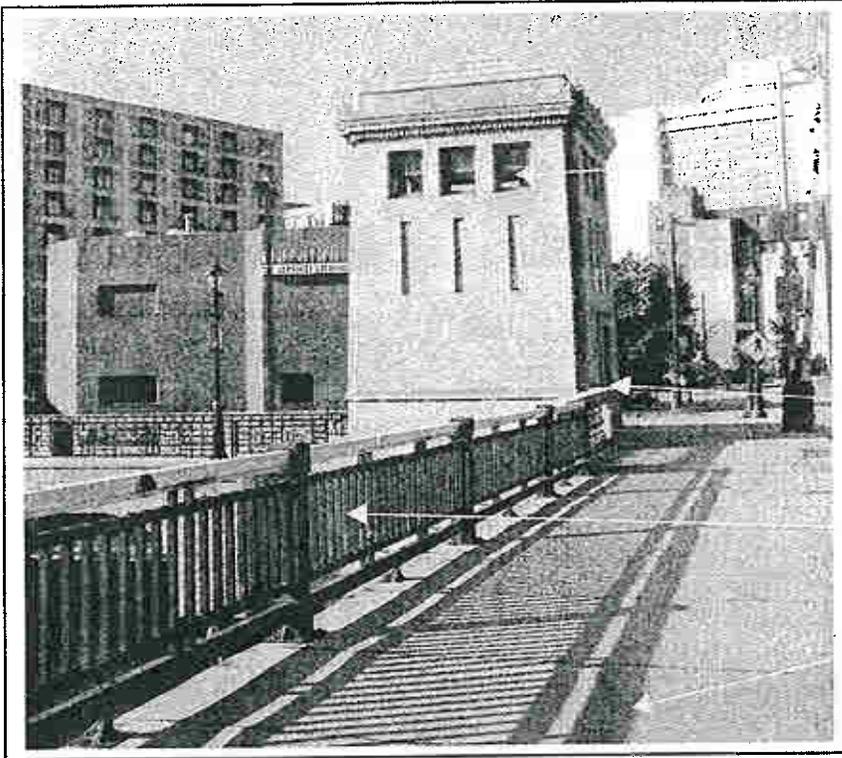
Photo #3 Railing and Northeast Pylon

Existing windows to be replaced

Existing door to be replaced

Existing railing to be rehabilitated

Existing sidewalk decking to be replaced with ipe wood

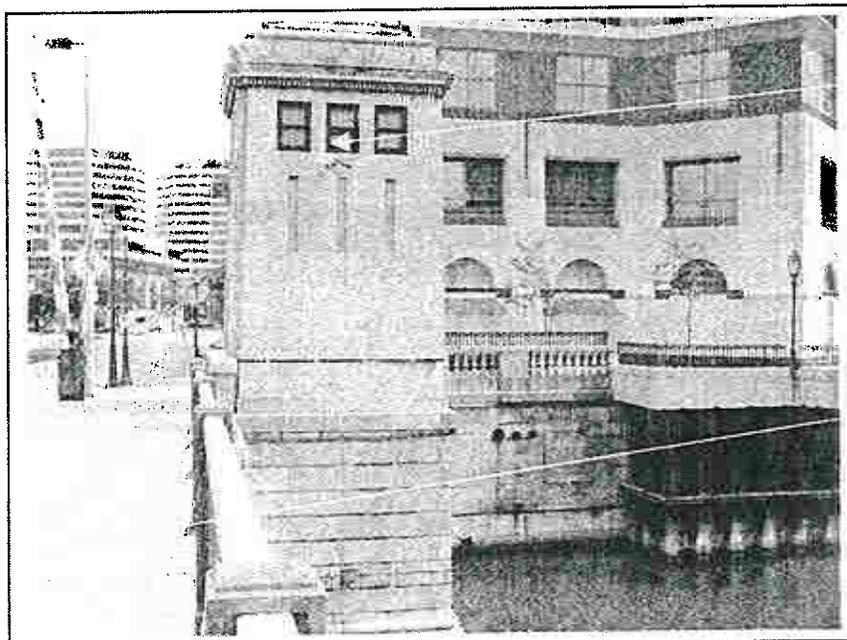
Photo #4 Sidewalk decking, Pier and Southeast Bridgehouse

Existing windows to be replaced

Existing sidewalk decking to be replaced with ipe wood

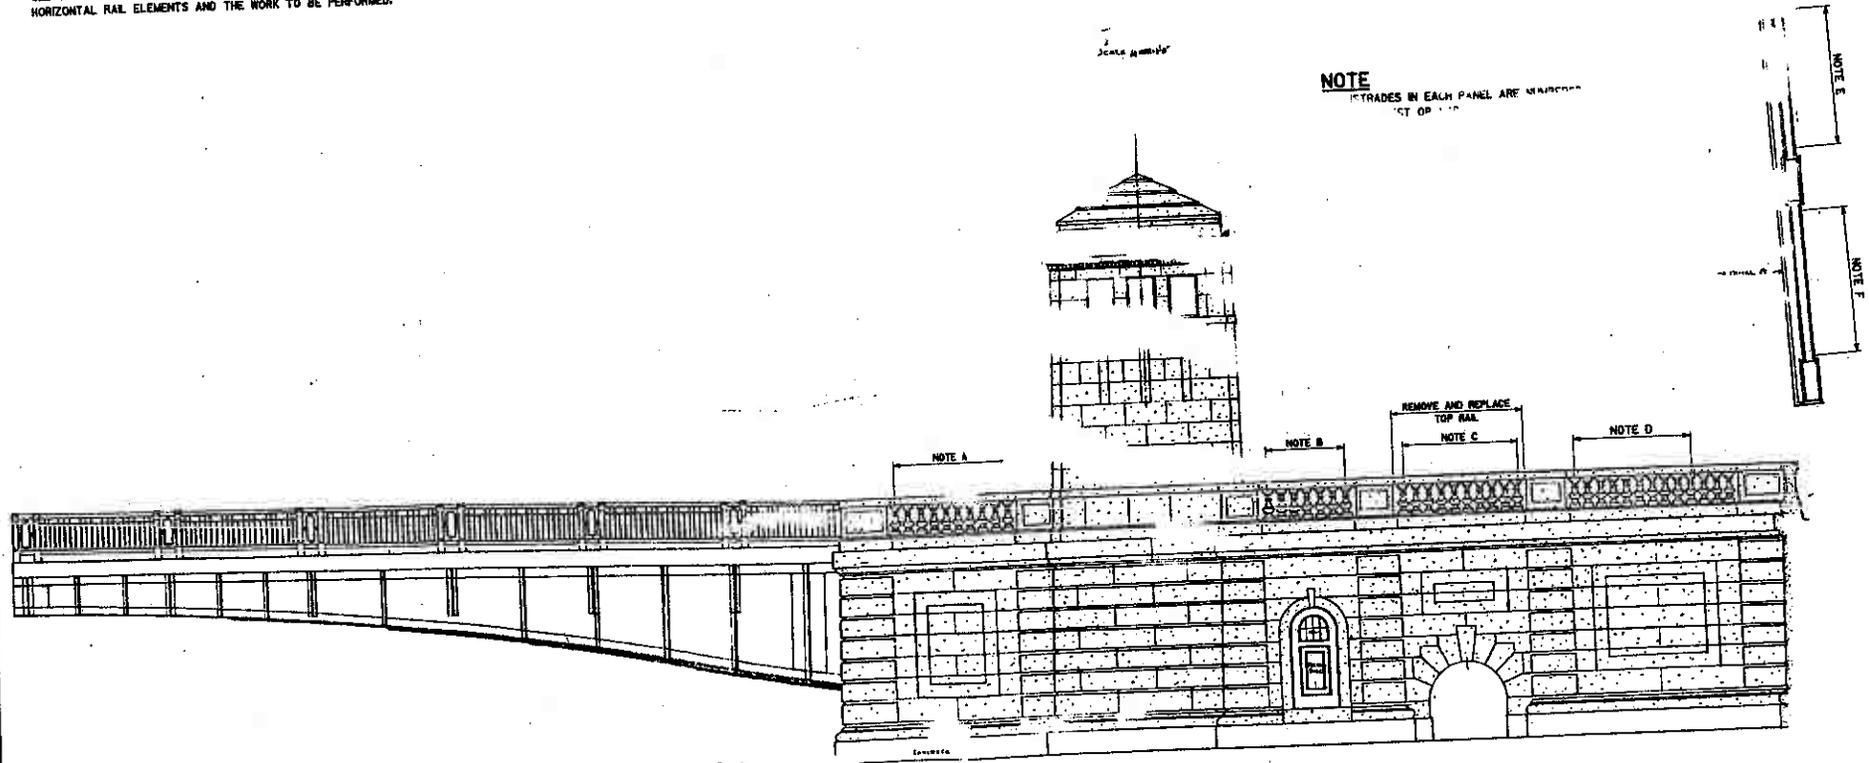
NORTHWEST ELEVATION

- NOTE A: 10 BALUSTRADES TOTAL, REPLACE NONE; PATCH NONE
 - NOTE B: 7 BALUSTRADES TOTAL, REPLACE NONE; PATCH NUMBERS 2,3,4,5,6
 - NOTE C: 10 BALUSTRADES TOTAL, REPLACE NUMBERS 6,8,9,10; PATCH NUMBER 3.
 - NOTE D: 13 BALUSTRADES TOTAL, REPLACE NUMBERS 2,4,7,9,10,13; PATCH NUMBERS 5,8.
 - NOTE E: 11 BALUSTRADES TOTAL, REPLACE ALL. EXISTING ARE CONCRETE REPLACEMENTS OF ORIGINALS.
 - NOTE F: 11 BALUSTRADES TOTAL, REPLACE ALL. EXISTING ARE CONCRETE REPLACEMENTS OF ORIGINALS.
- SEE SPECIAL PROVISIONS FOR FIELD INSPECTION OF TOP AND BOTTOM HORIZONTAL RAIL ELEMENTS AND THE WORK TO BE PERFORMED.
