**Engineering Evaluation of the  
Estabrook Park Dam on the  
Milwaukee River  
Milwaukee, Wisconsin**

Milwaukee County  
Department of Public Works

STS Project No. 5-87996

September 8, 2006

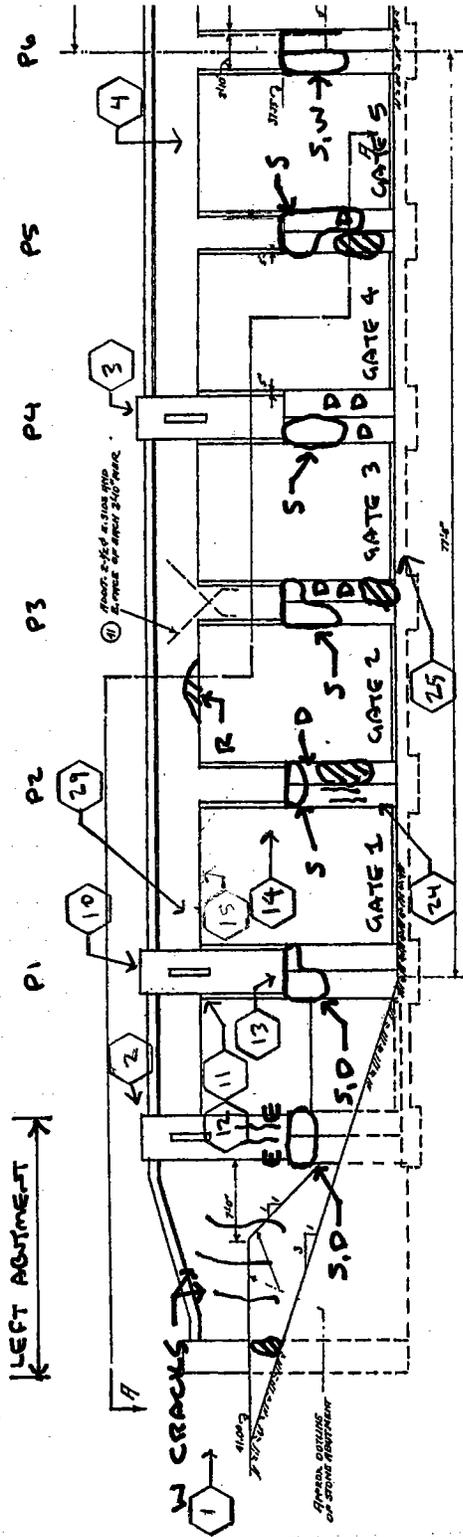
FIGURE 1

The upstream operating bridge wall was in generally fair condition, with isolated areas of deterioration, as observed from the operating bridge. STS observed top of wall cracking at pier numbers 5 and 11 (see Figure 1 and 2 in Appendix C). There was also a full height wall crack in the upstream operating bridge wall near pier number 2. Vertical wall reinforcement cover spalls were present in the wall on the downstream side near gate number 5 (2 spalls), and pier number 2 (1 spall). STS observed concrete disintegration at the top of the wall at pier number 1. Cracking and delaminations were present over the wall at expansion joint number 1. The downstream face of the wall at the right abutment pier exhibited cracking, efflorescence, and isolated disintegration.

PROJECT <b>ESTABROOK PARK DAM, MILWAUKEE, WISCONSIN</b>			STS JOB NO. <b>X587996</b>	
	SUBJECT <b>UPSTREAM CONDITION OBSERVATIONS</b>			SHEET NO. <b>1 OF 1</b>	
ORIGINATED BY <b>JMK</b>	DATE <b>FEB. 3, 2006</b>	CHECKED BY	DATE	CALC. NO.	REV. NO.
STS Consultants Ltd. CALCULATION SHEET

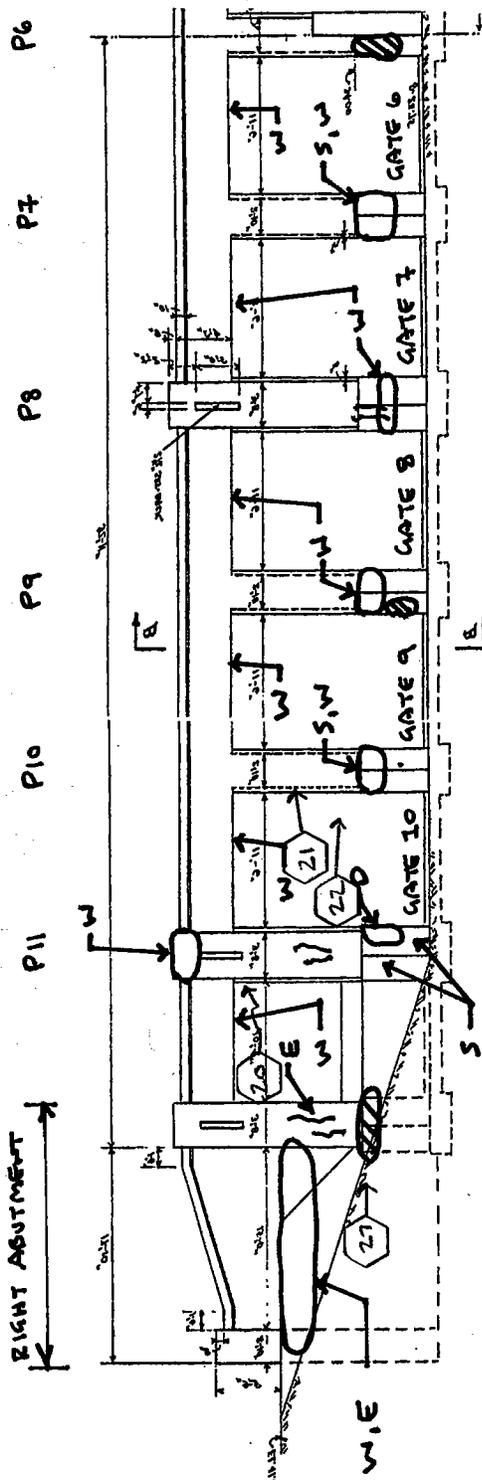
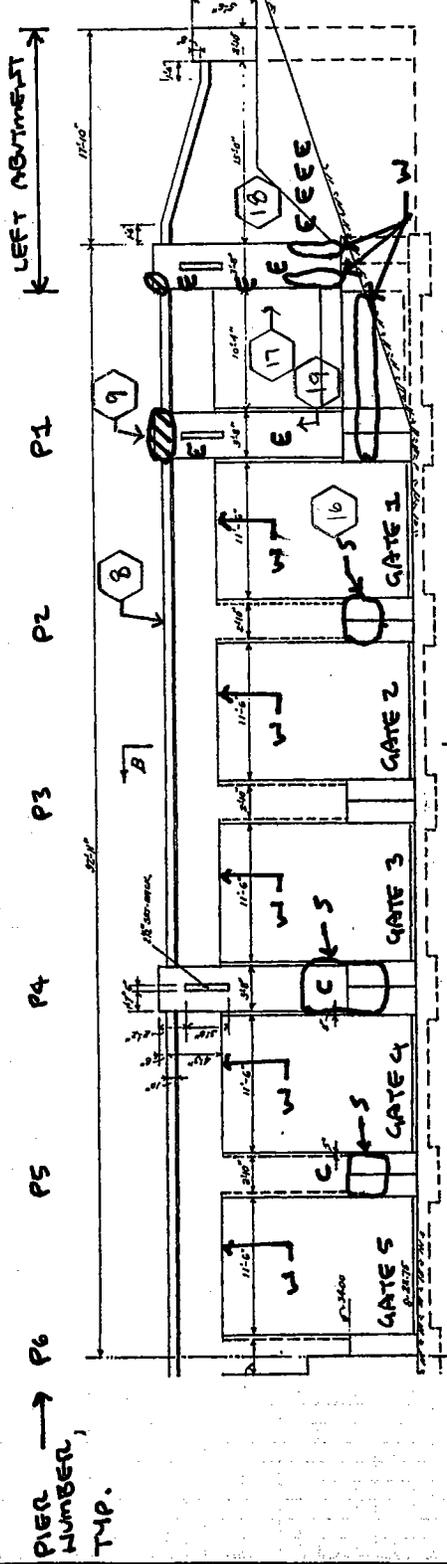
FIGURE 2

PROJECT <b>ESTABROOK PARK DAM, MILWAUKEE, WISCONSIN</b>				STS JOB NO. <b>X587996</b>	
SUBJECT <b>DOWNSTREAM CONDITION OBSERVATIONS</b>				SHEET NO. <b>1</b> OF <b>1</b>	
ORIGINATED BY <b>JMK</b>	DATE <b>FEB. 3, 2006</b>	CHECKED BY	DATE	CALC. NO.	REV. NO.

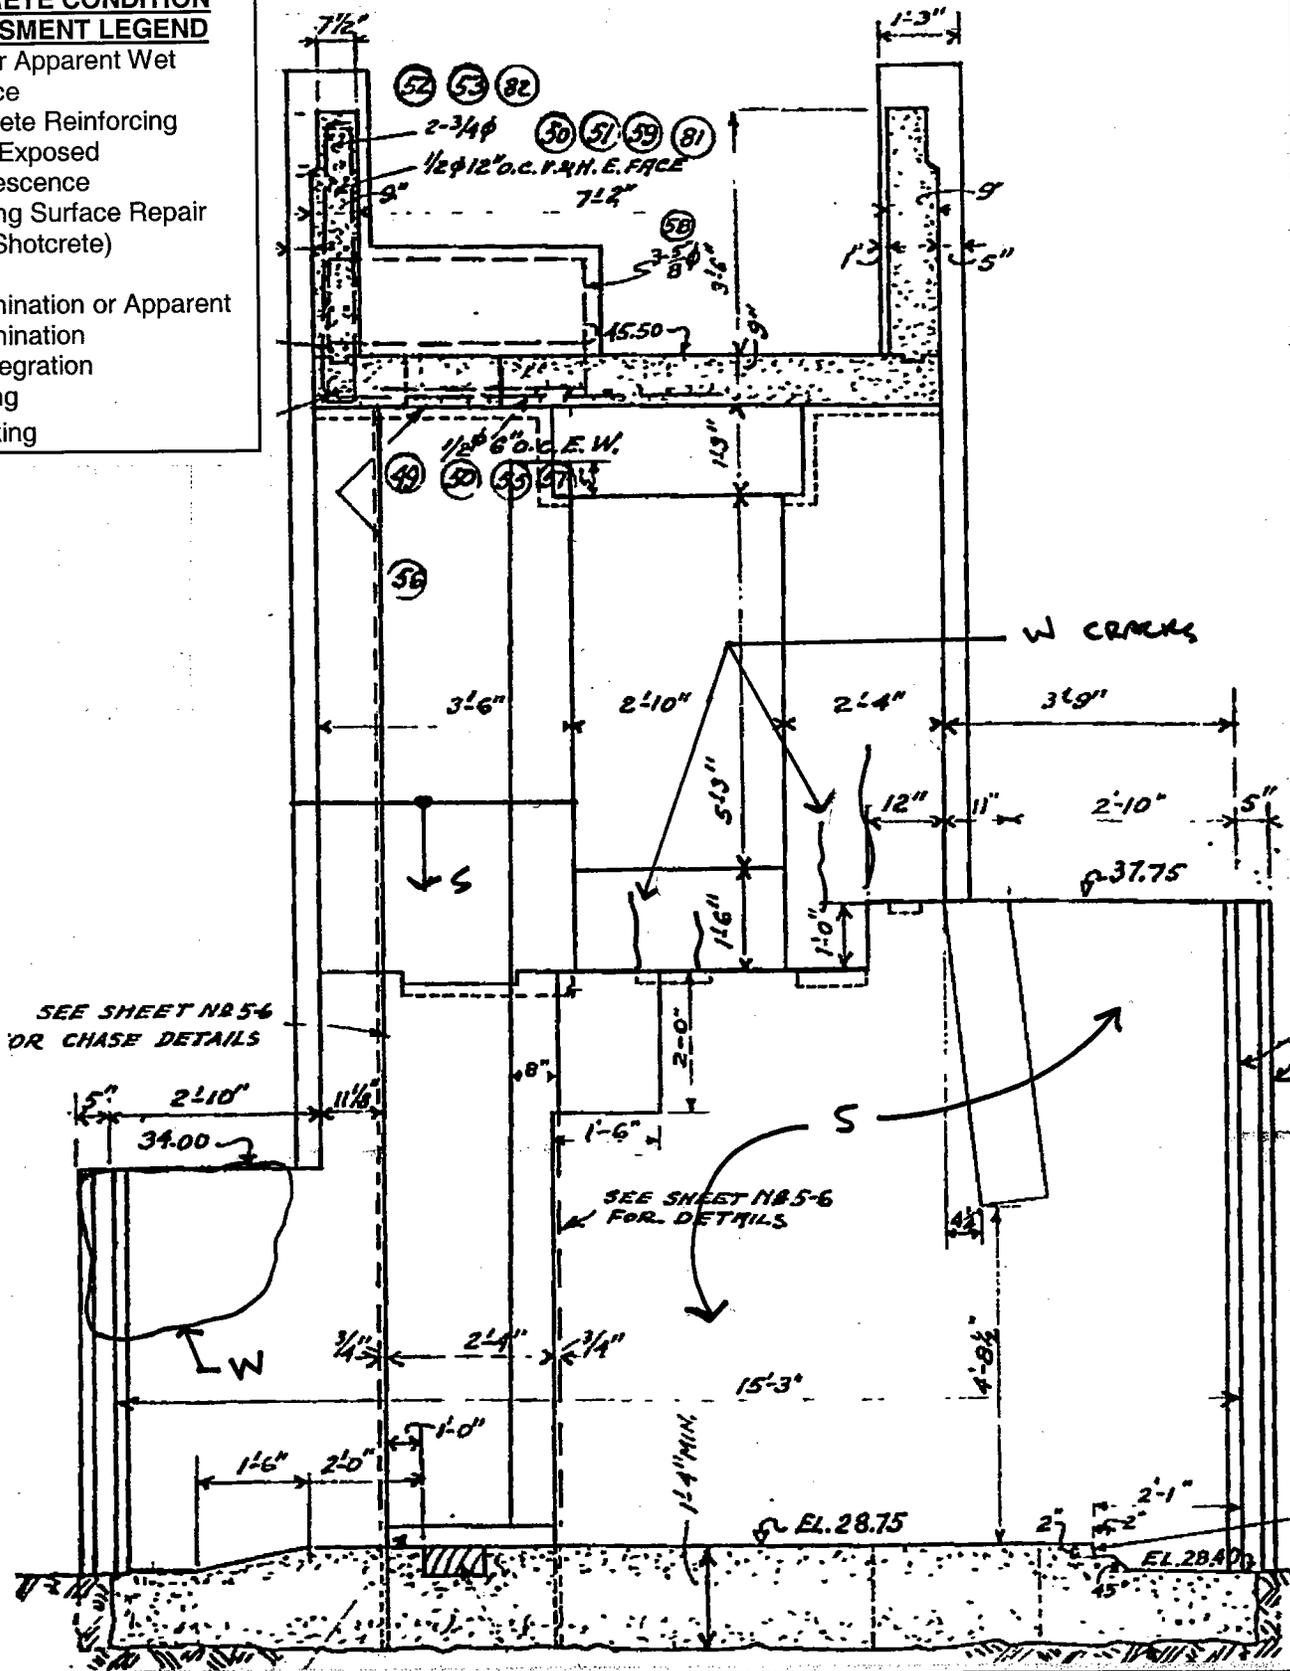
FIGURE 8

SUBJECT  
PIER 4 - LEFT SIDE CONDITION OBSERVATIONS

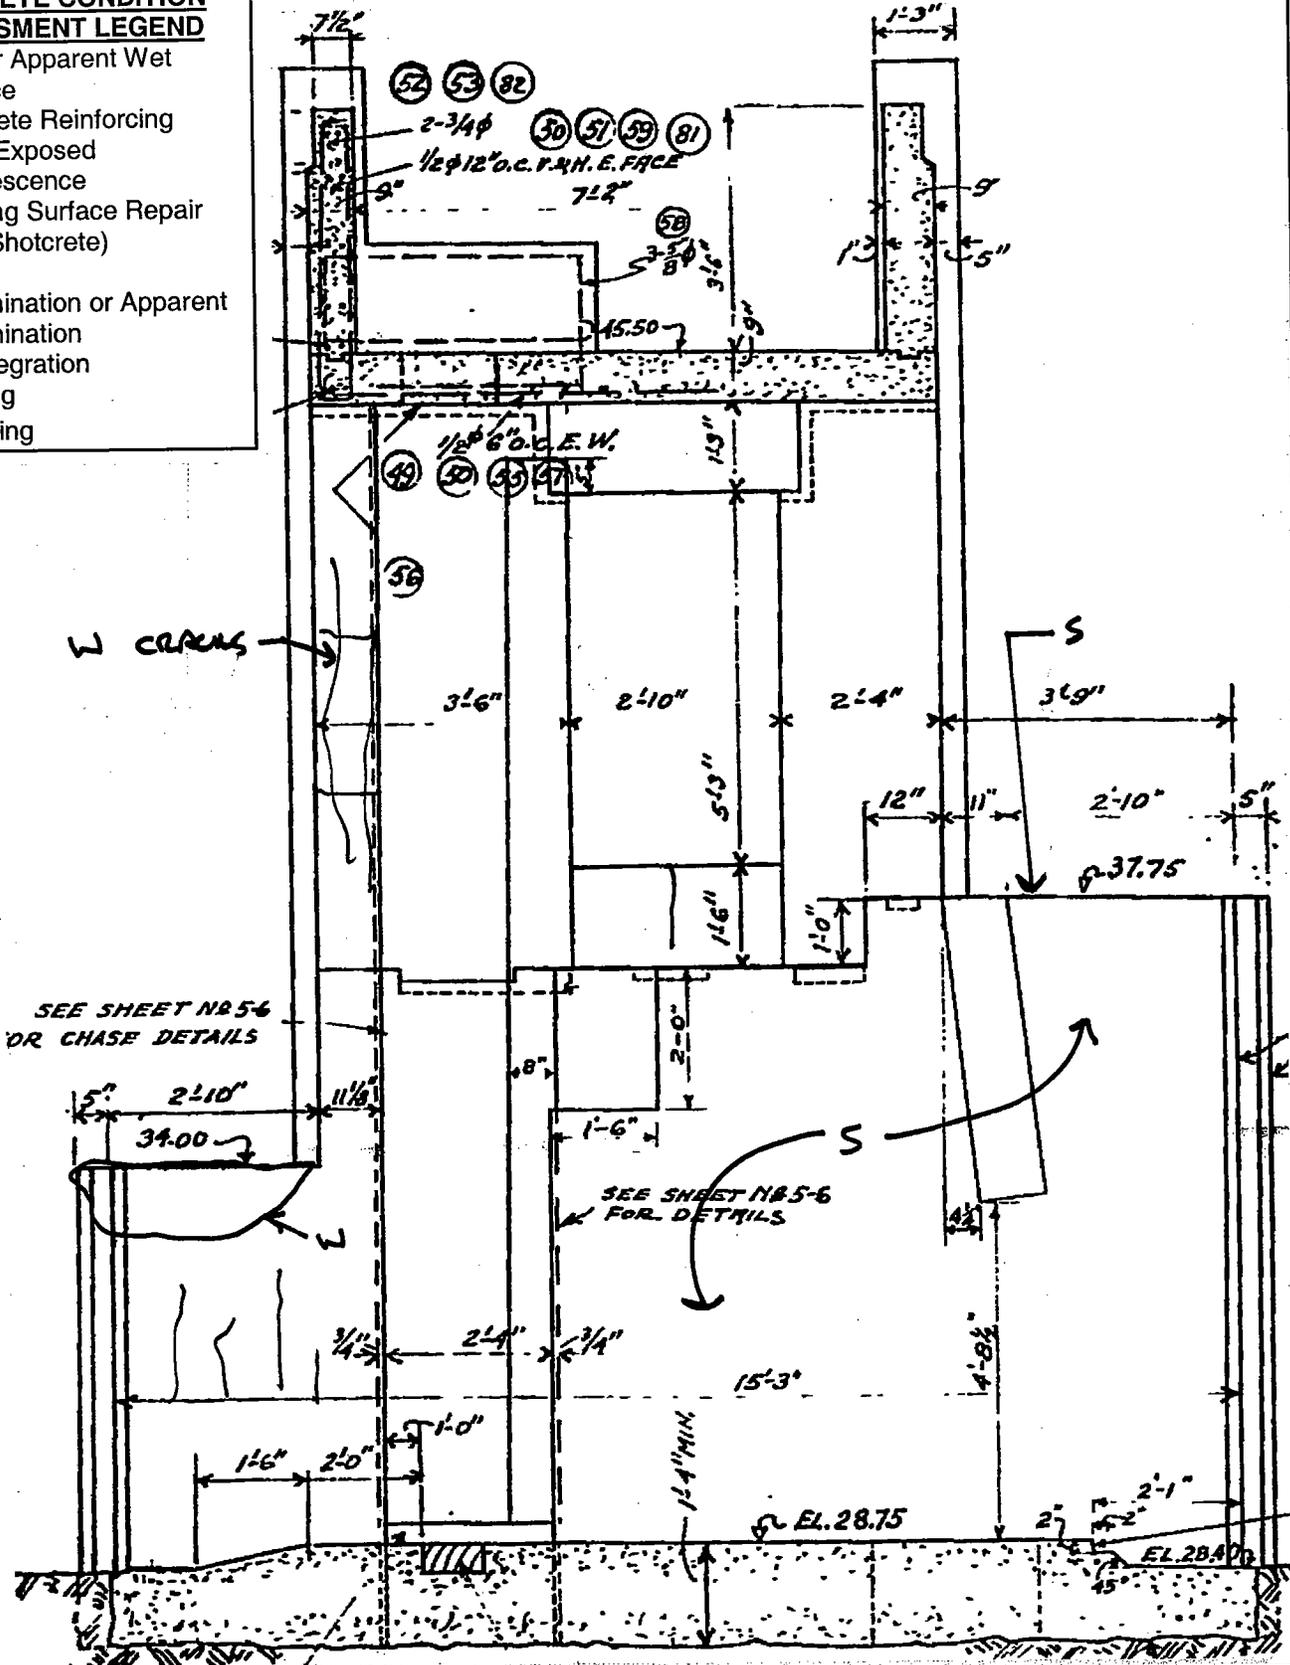
FIGURE 9

<p><b>STS Consultants Ltd.</b> CALCULATION SHEET</p>	PROJECT <b>ESTABROOK PARK DAM, MILWAUKEE, WISCONSIN</b>				STS JOB NO. <b>X587996</b>	
	SUBJECT <b>PIER 6 - LEFT SIDE CONDITION OBSERVATIONS</b>				SHEET NO. <b>1</b> OF <b>1</b>	
	ORIGINATED BY <b>JMK</b>	DATE <b>FEB. 3, 2006</b>	CHECKED BY	DATE	CALC. NO.	REV. NO.

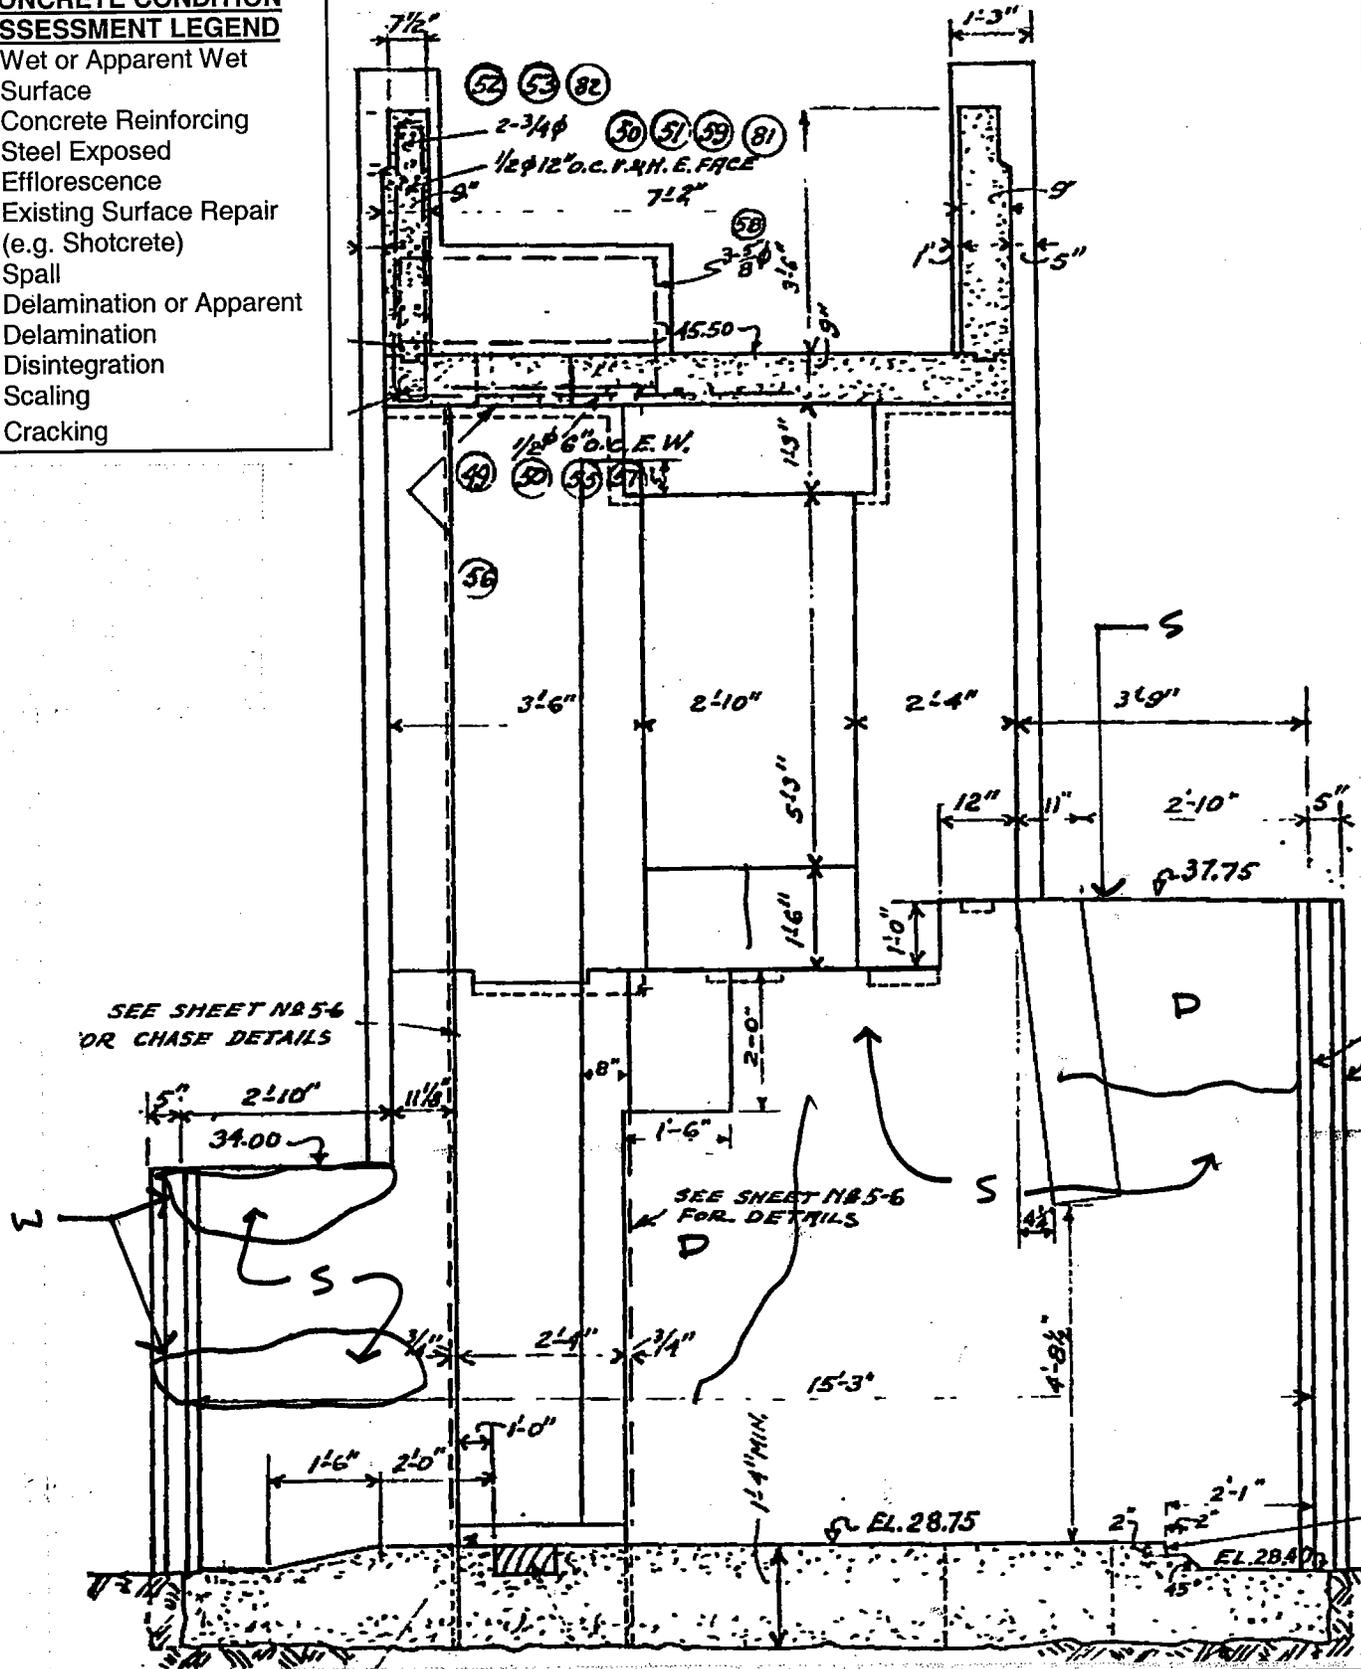
FIGURE 10

SUBJECT  
PIER 7 - LEFT SIDE CONDITION OBSERVATIONS

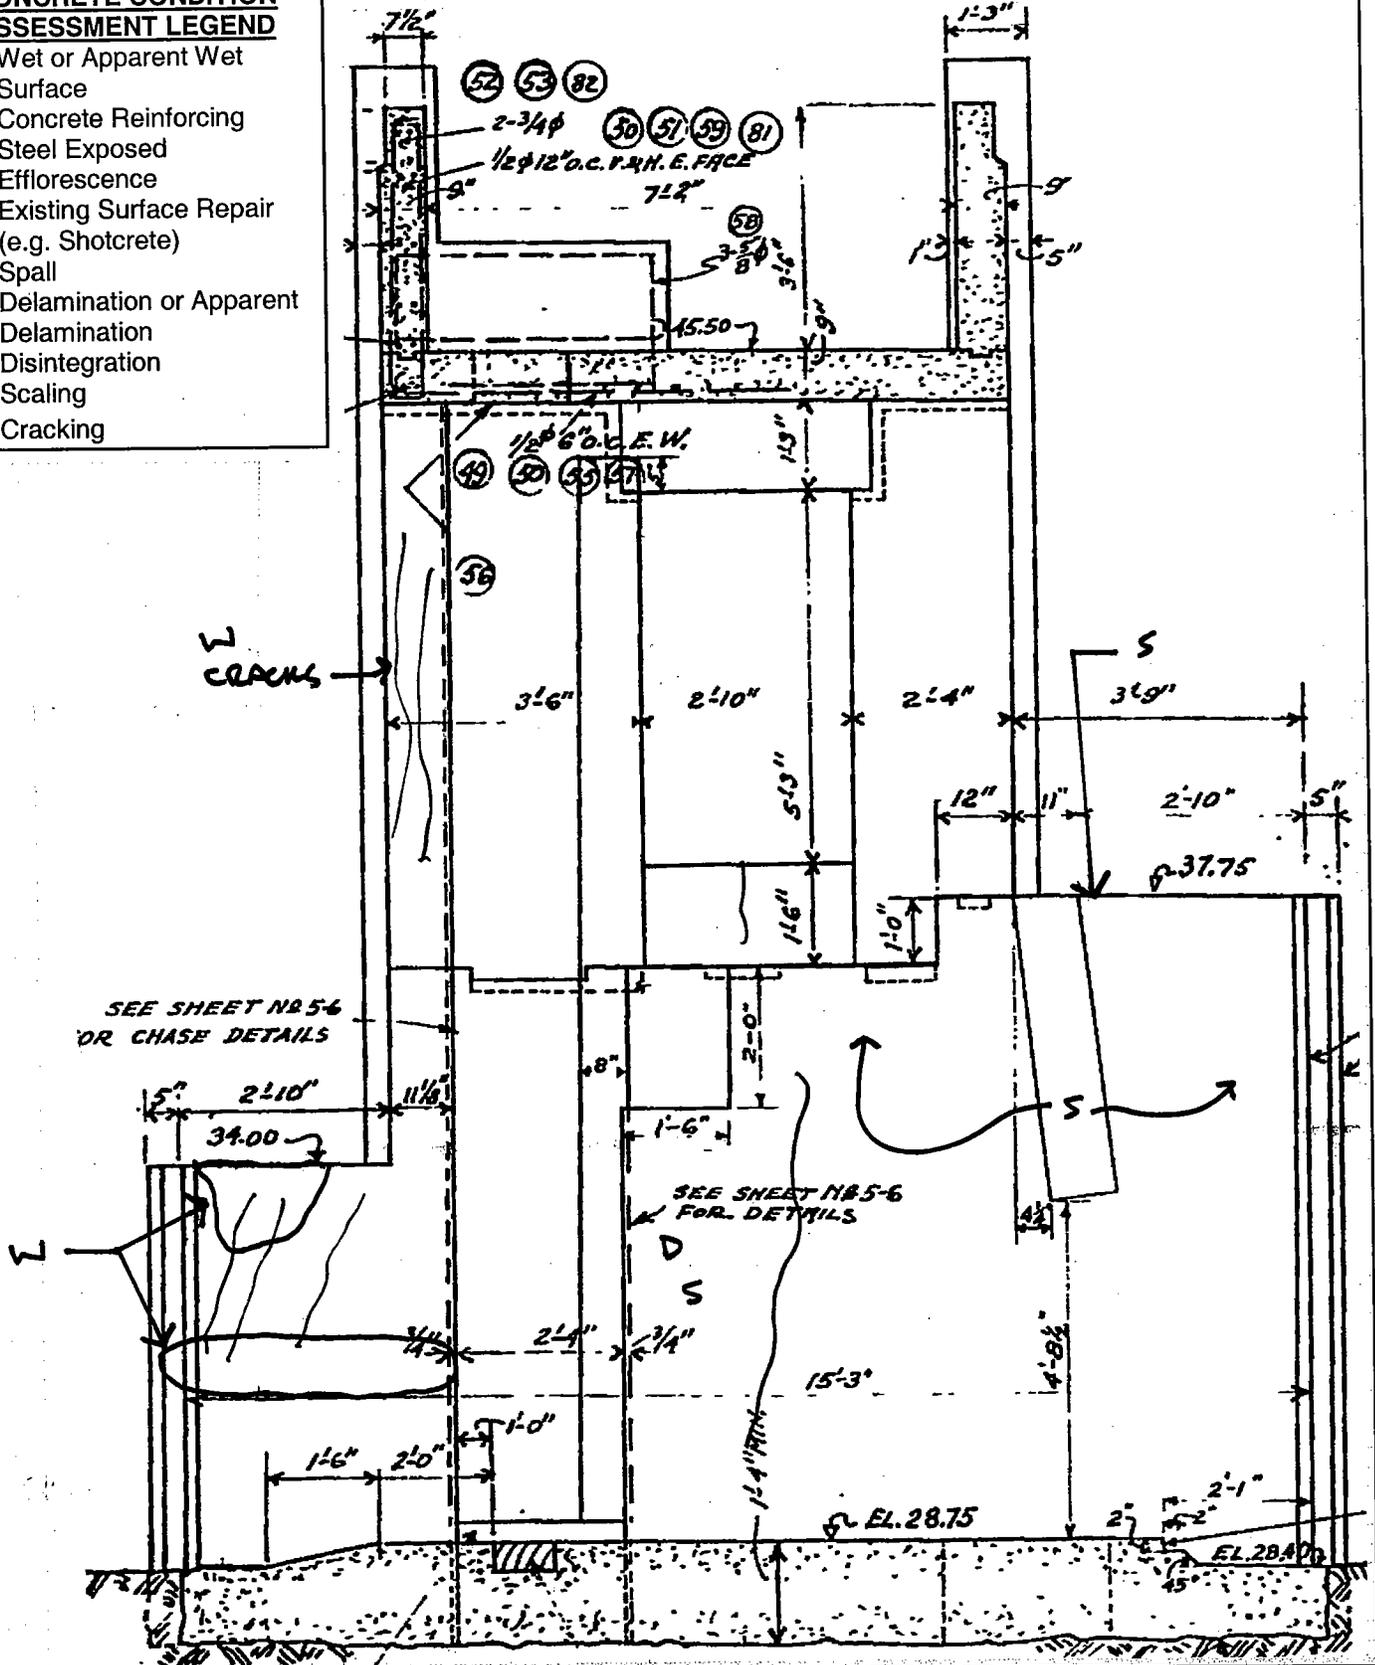
FIGURE 12

<b>STS Consultants Ltd.</b> CALCULATION SHEET	PROJECT <b>ESTABROOK PARK DAM, MILWAUKEE, WISCONSIN</b>				STS JOB NO. <b>X587996</b>	
	SUBJECT <b>PIER 8 - LEFT SIDE CONDITION OBSERVATIONS</b>				SHEET NO. <b>1</b> OF <b>1</b>	
	ORIGINATED BY <b>JMK</b>	DATE <b>FEB. 3, 2006</b>	CHECKED BY	DATE	CALC. NO.	REV. NO.

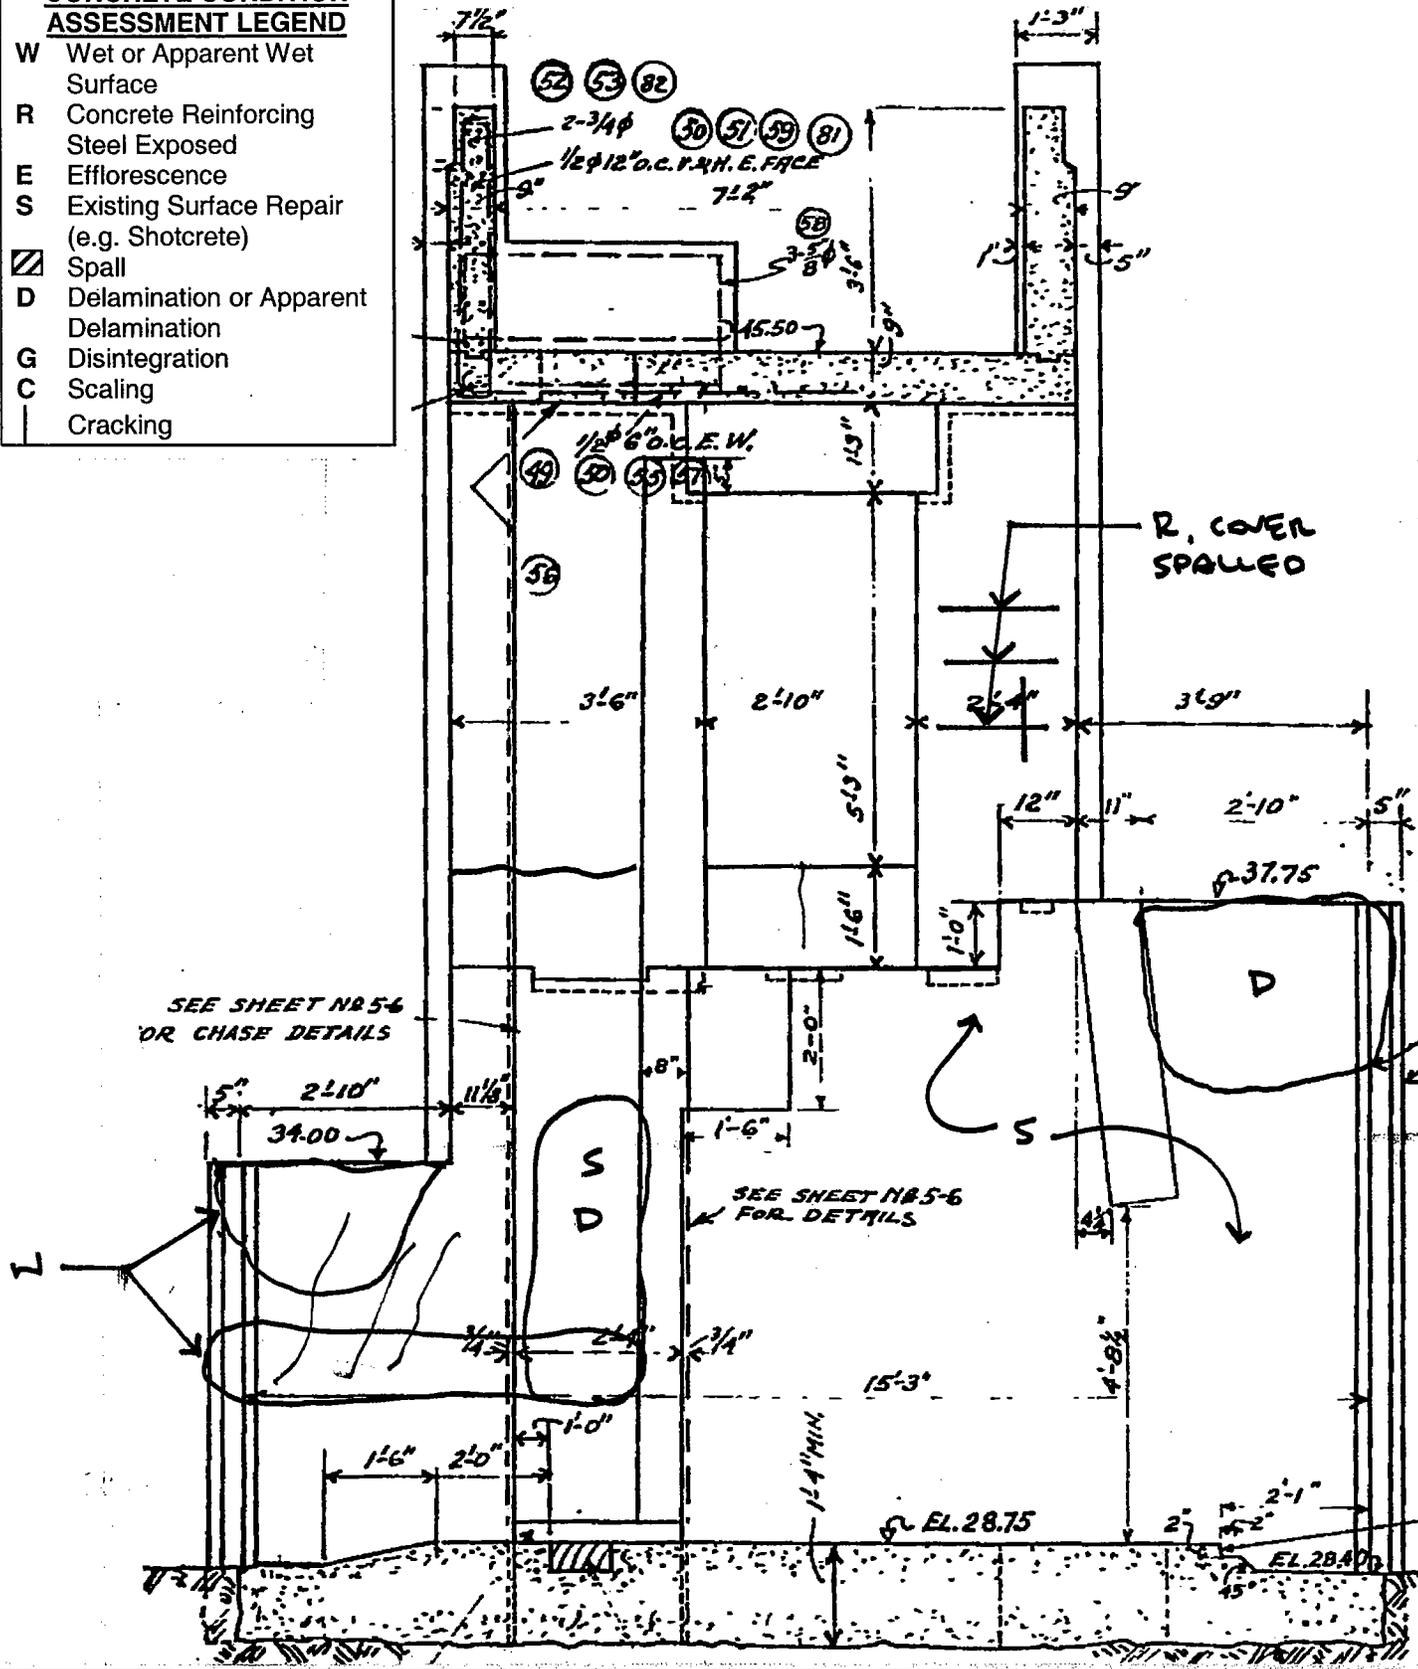
FIGURE 14

PROJECT <b>ESTABROOK PARK DAM, MILWAUKEE, WISCONSIN</b>		STS JOB NO. <b>X587996</b>	
SUBJECT <b>PIER 10 – LEFT SIDE CONDITION OBSERVATIONS</b>		SHEET NO. <b>1 OF 1</b>	
ORIGINATED BY <b>JMK</b>	DATE <b>FEB. 3, 2006</b>	CHECKED BY	DATE
CALC. NO.		REV. NO.

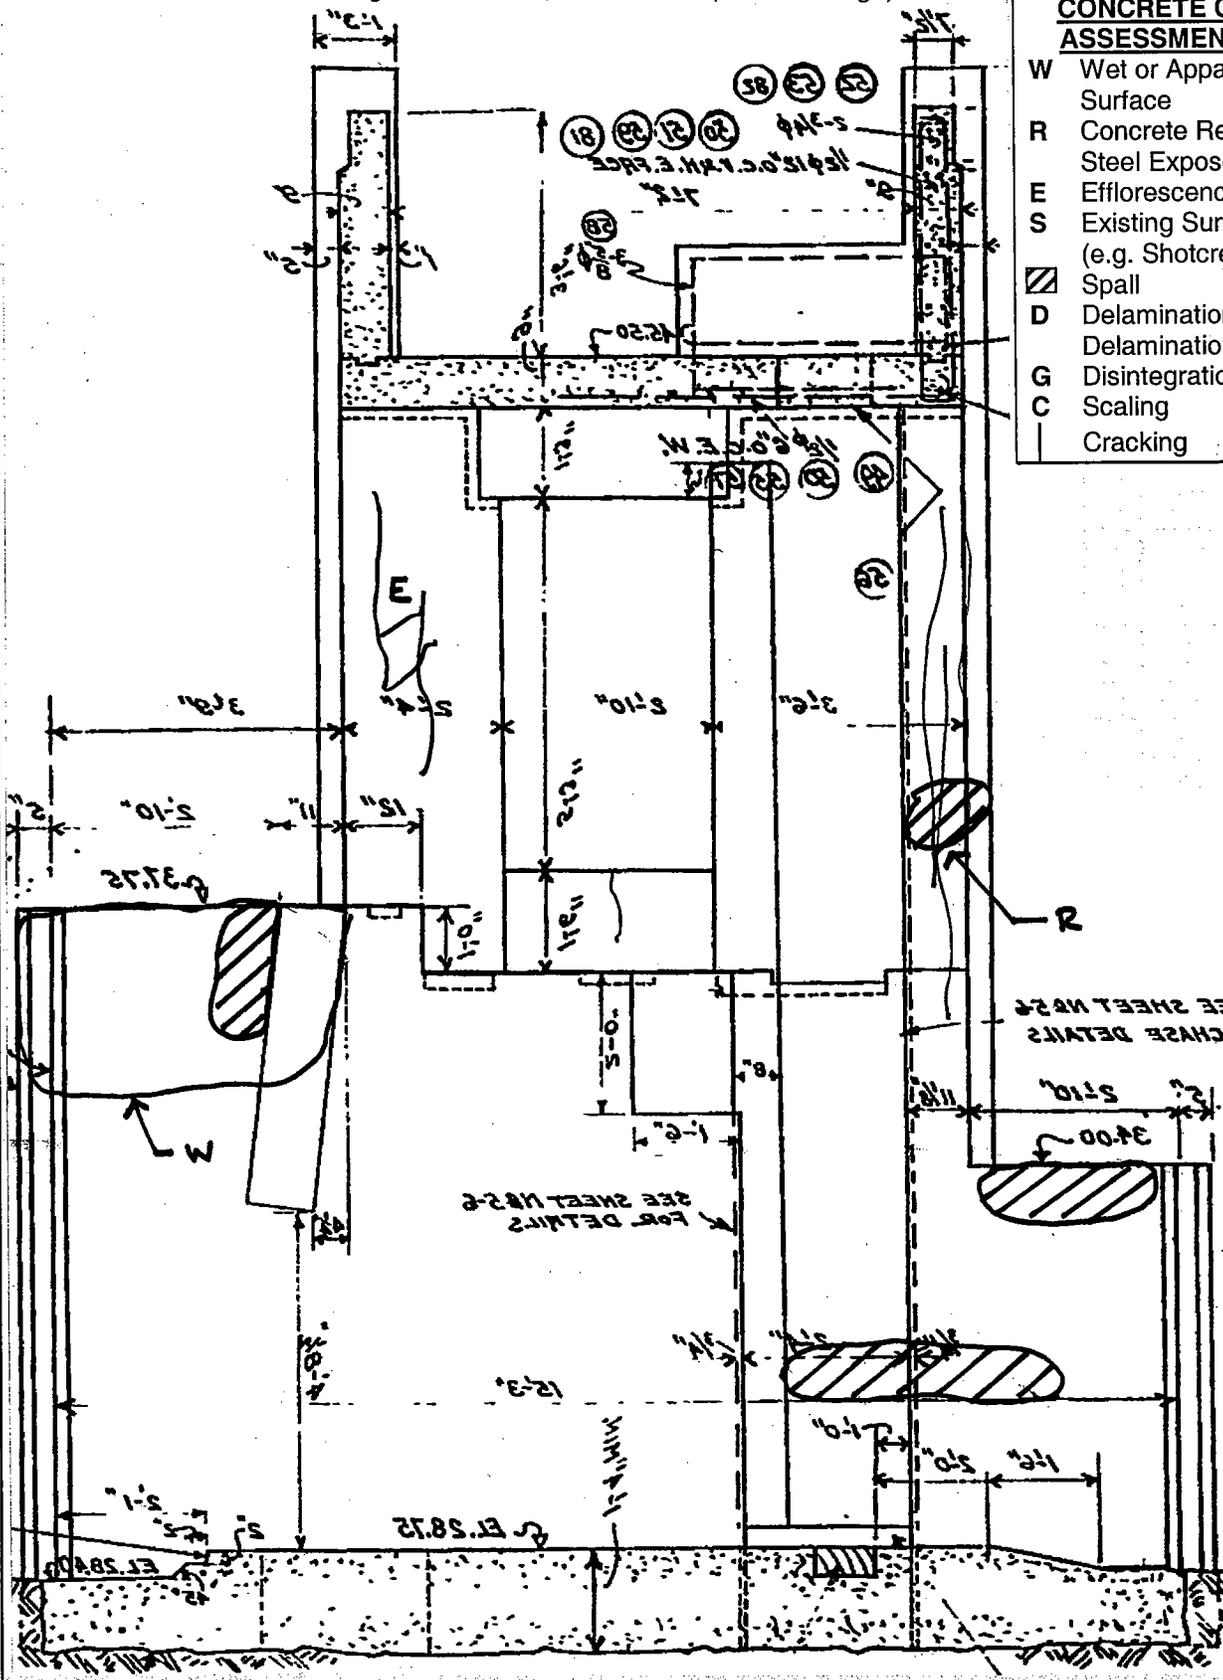
FIGURE 16

<b>STS Consultants Ltd.</b> CALCULATION SHEET	PROJECT <b>ESTABROOK PARK DAM, MILWAUKEE, WISCONSIN</b>			STS JOB NO. <b>X587996</b>	
	SUBJECT <b>PIER 1 - RIGHT SIDE CONDITION OBSERVATIONS</b>			SHEET NO. <b>1</b> OF <b>1</b>	
	ORIGINATED BY <b>JMK</b>	DATE <b>FEB. 3, 2006</b>	CHECKED BY	DATE	CALC. NO.

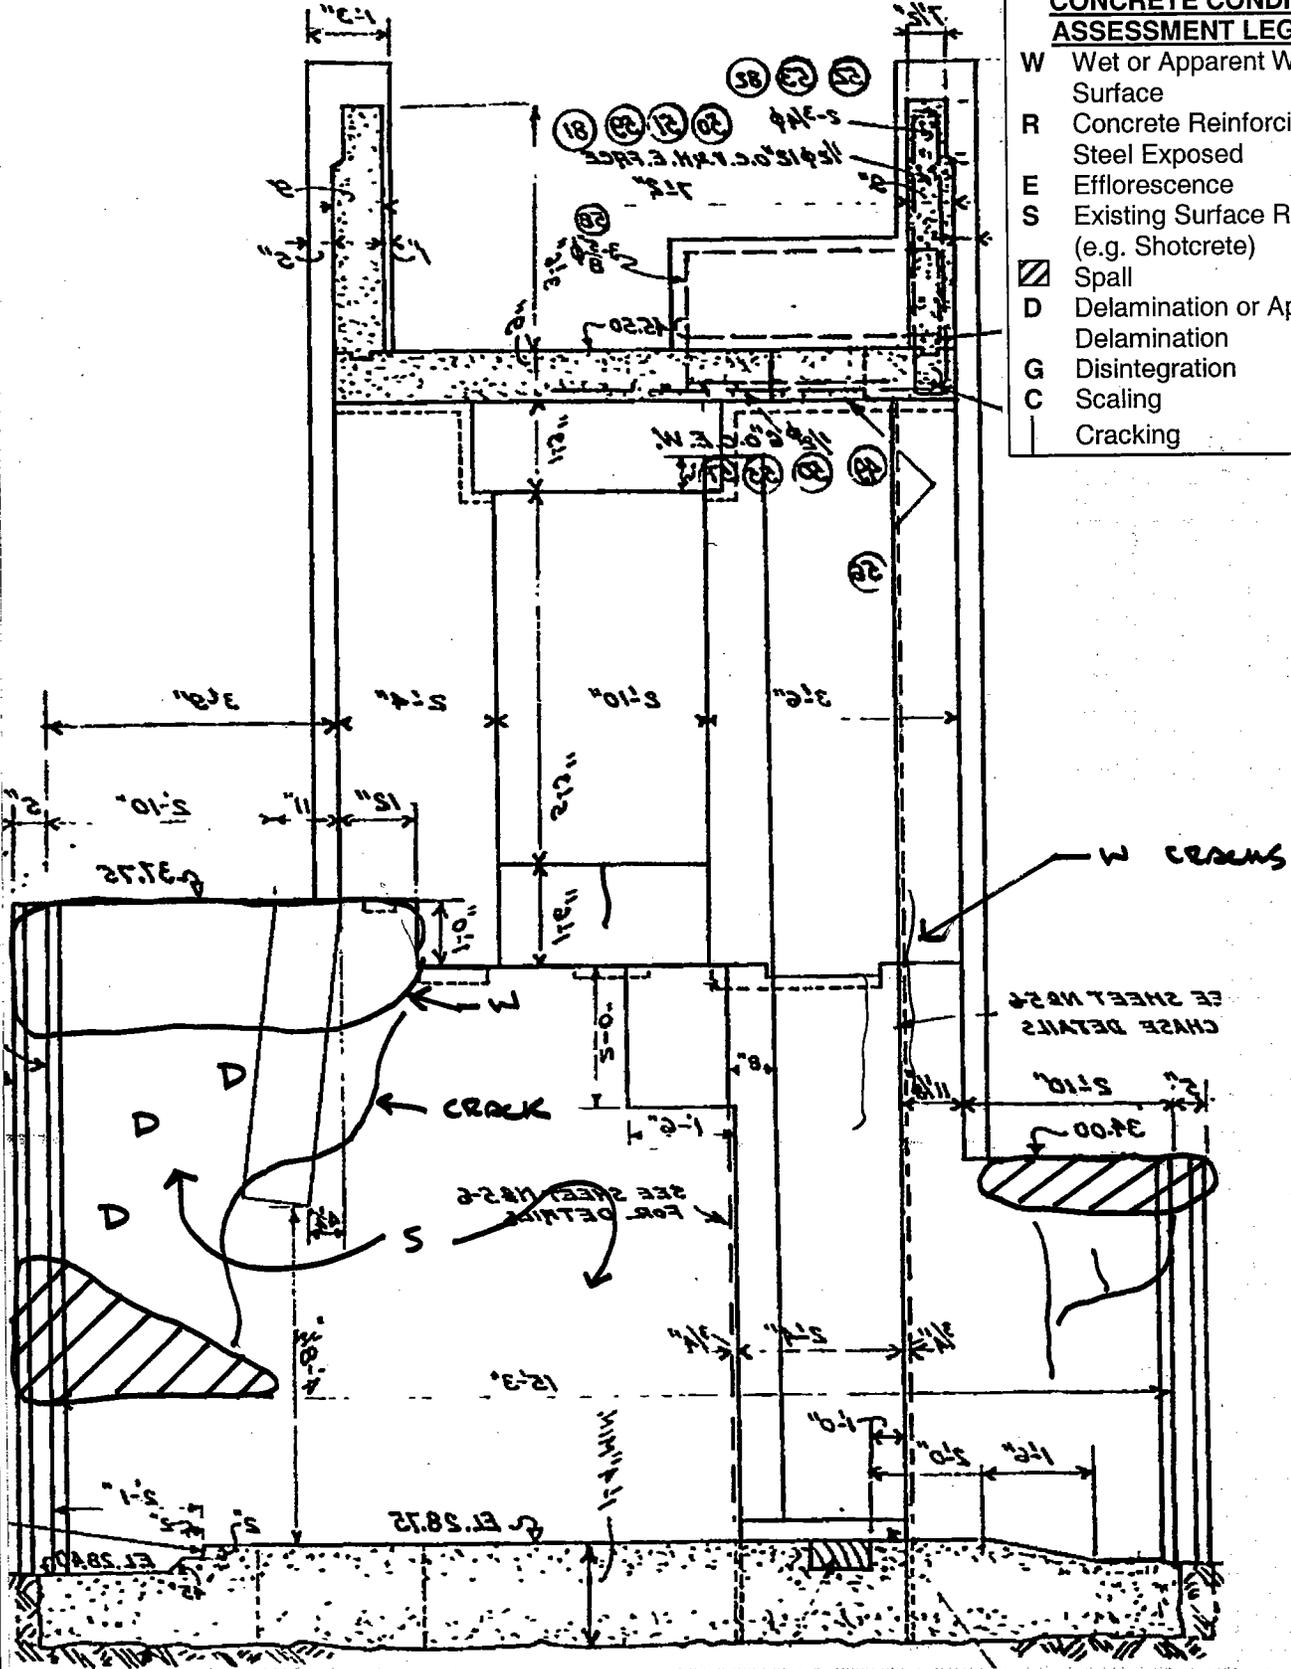
FIGURE 17

<b>STS Consultants Ltd.</b> CALCULATION SHEET	PROJECT <b>ESTABROOK PARK DAM, MILWAUKEE, WISCONSIN</b>		STS JOB NO. <b>X587996</b>		
	SUBJECT <b>PIER 3 - RIGHT SIDE CONDITION OBSERVATIONS</b>		SHEET NO. <b>1</b> OF <b>1</b>		
	ORIGINATED BY <b>JMK</b>	DATE <b>FEB. 3, 2006</b>	CHECKED BY	DATE	CALC. NO.

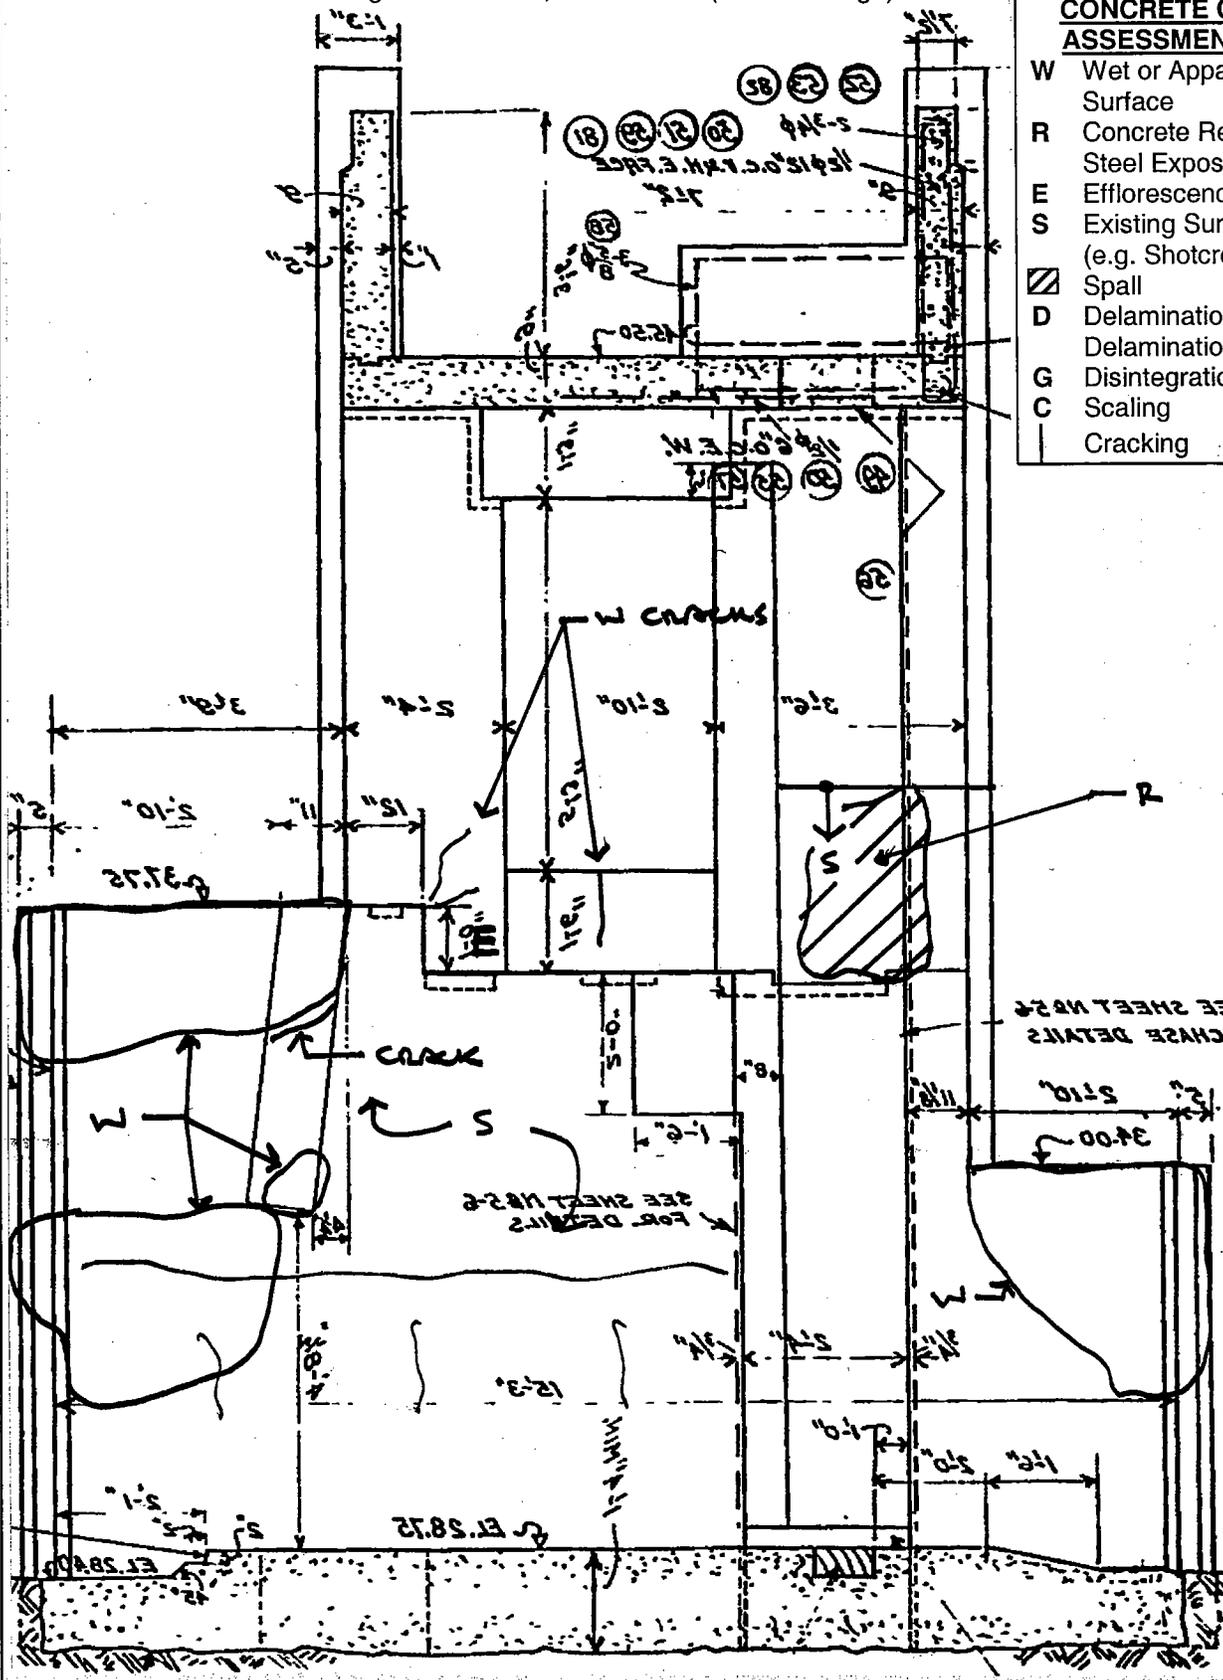
FIGURE 18

<p><b>STS Consultants Ltd.</b> CALCULATION SHEET</p>	PROJECT <b>ESTABROOK PARK DAM, MILWAUKEE, WISCONSIN</b>				STS JOB NO. <b>X587996</b>	
	SUBJECT <b>PIER 4 - RIGHT SIDE CONDITION OBSERVATIONS</b>				SHEET NO. <b>1</b> OF <b>1</b>	
	ORIGINATED BY <b>JMK</b>	DATE <b>FEB. 3, 2006</b>	CHECKED BY	DATE	CALC. NO.	REV. NO.

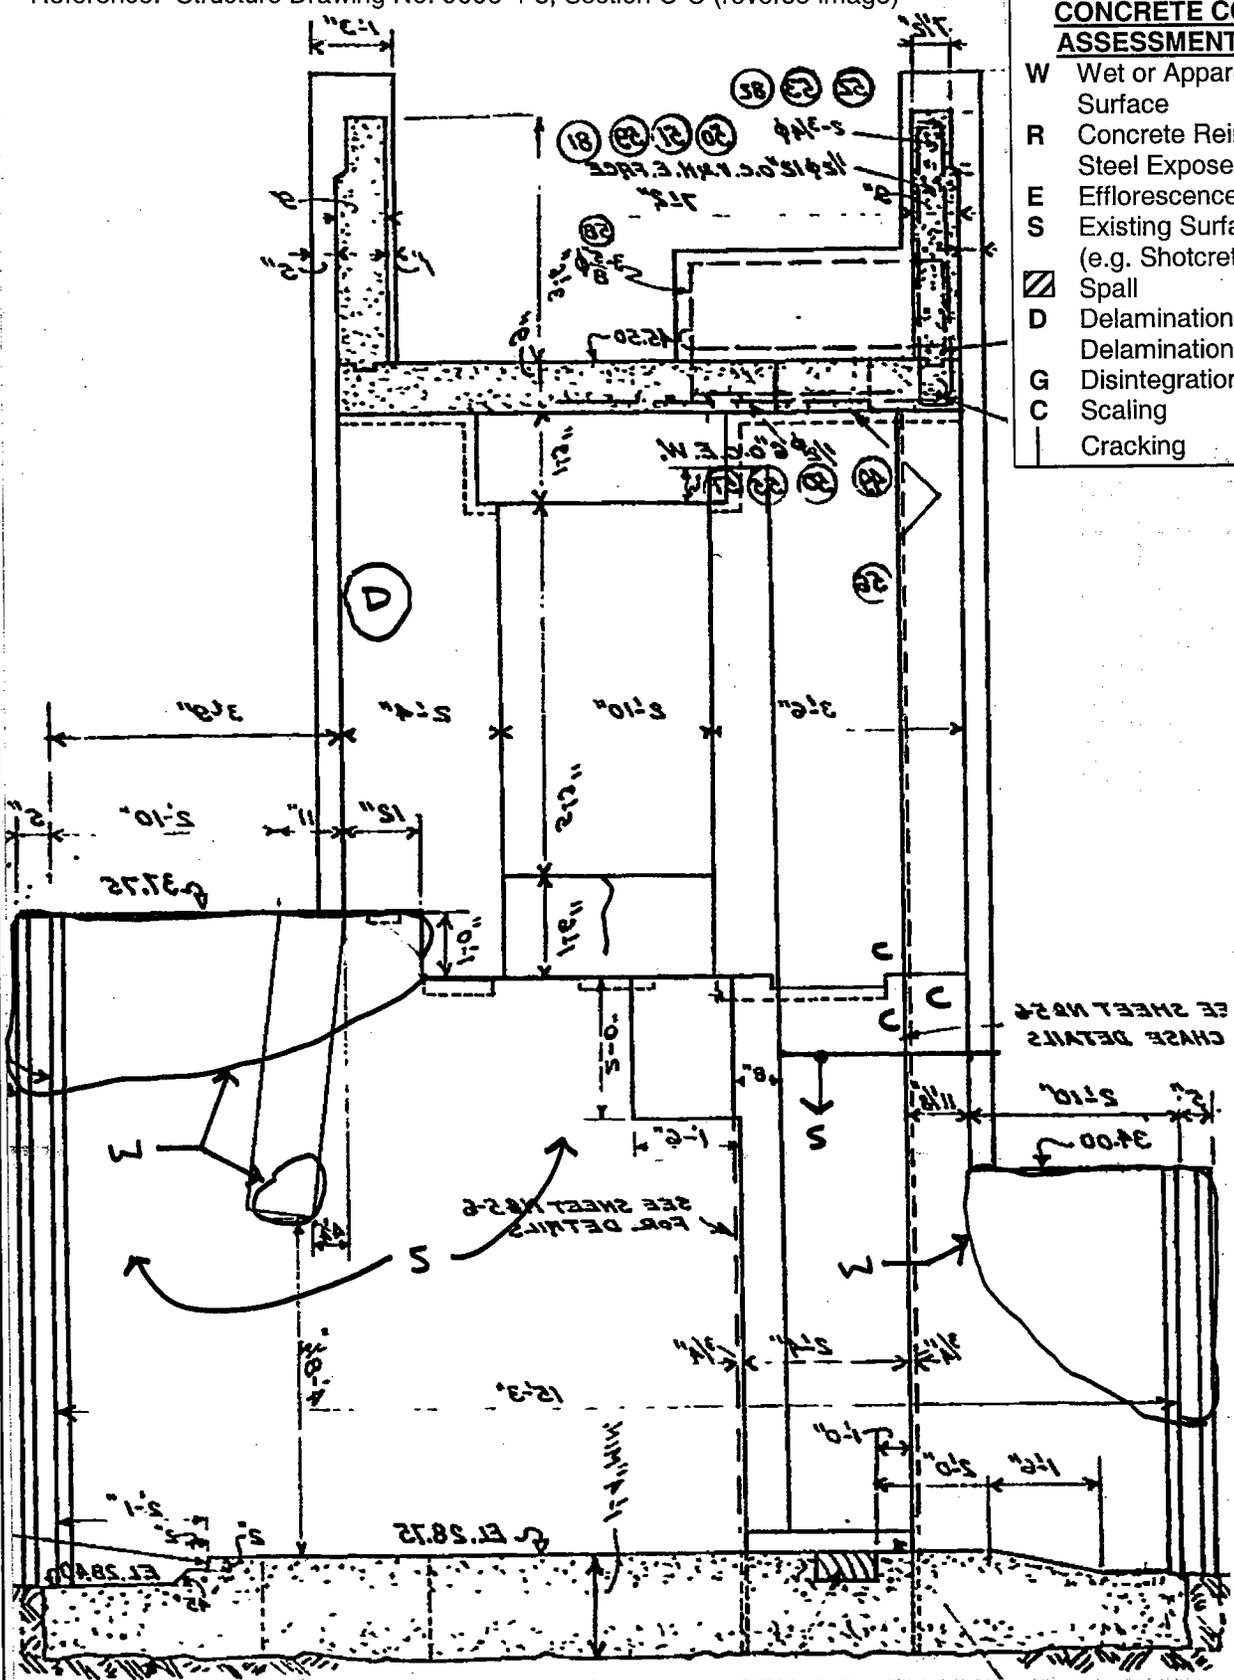
FIGURE 20

PROJECT <b>ESTABROOK PARK DAM, MILWAUKEE, WISCONSIN</b>		STS JOB NO. <b>X587996</b>	
SUBJECT <b>PIER 5 - RIGHT SIDE CONDITION OBSERVATIONS</b>		SHEET NO. <b>1</b> OF <b>1</b>	
ORIGINATED BY <b>JMK</b>	DATE <b>FEB. 3, 2006</b>	CHECKED BY	DATE
