**Engineering Evaluation of the  
Estabrook Park Dam on the  
Milwaukee River  
Milwaukee, Wisconsin**

Milwaukee County  
Department of Public Works

STS Project No. 5-87996

September 8, 2006

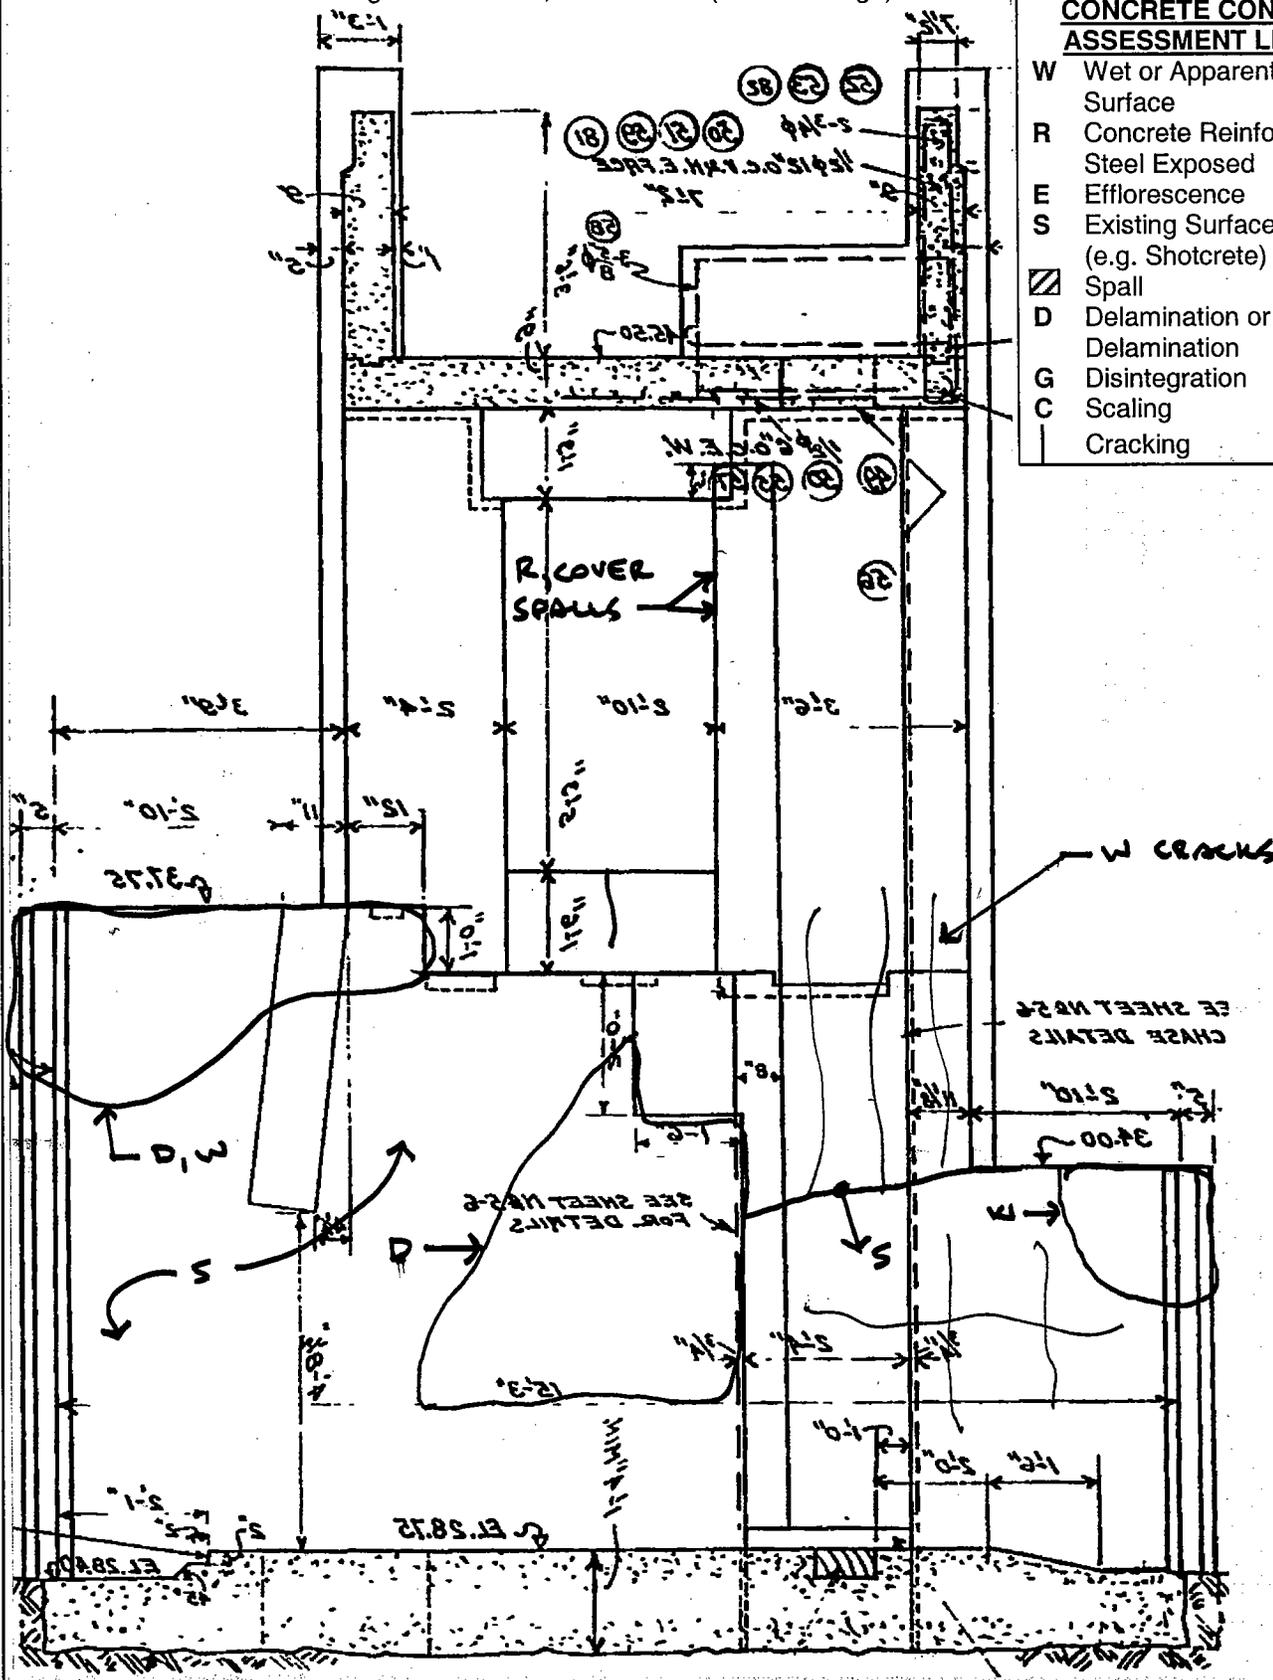
FIGURE 21

SUBJECT  
PIER 7 - RIGHT SIDE CONDITION OBSERVATIONS

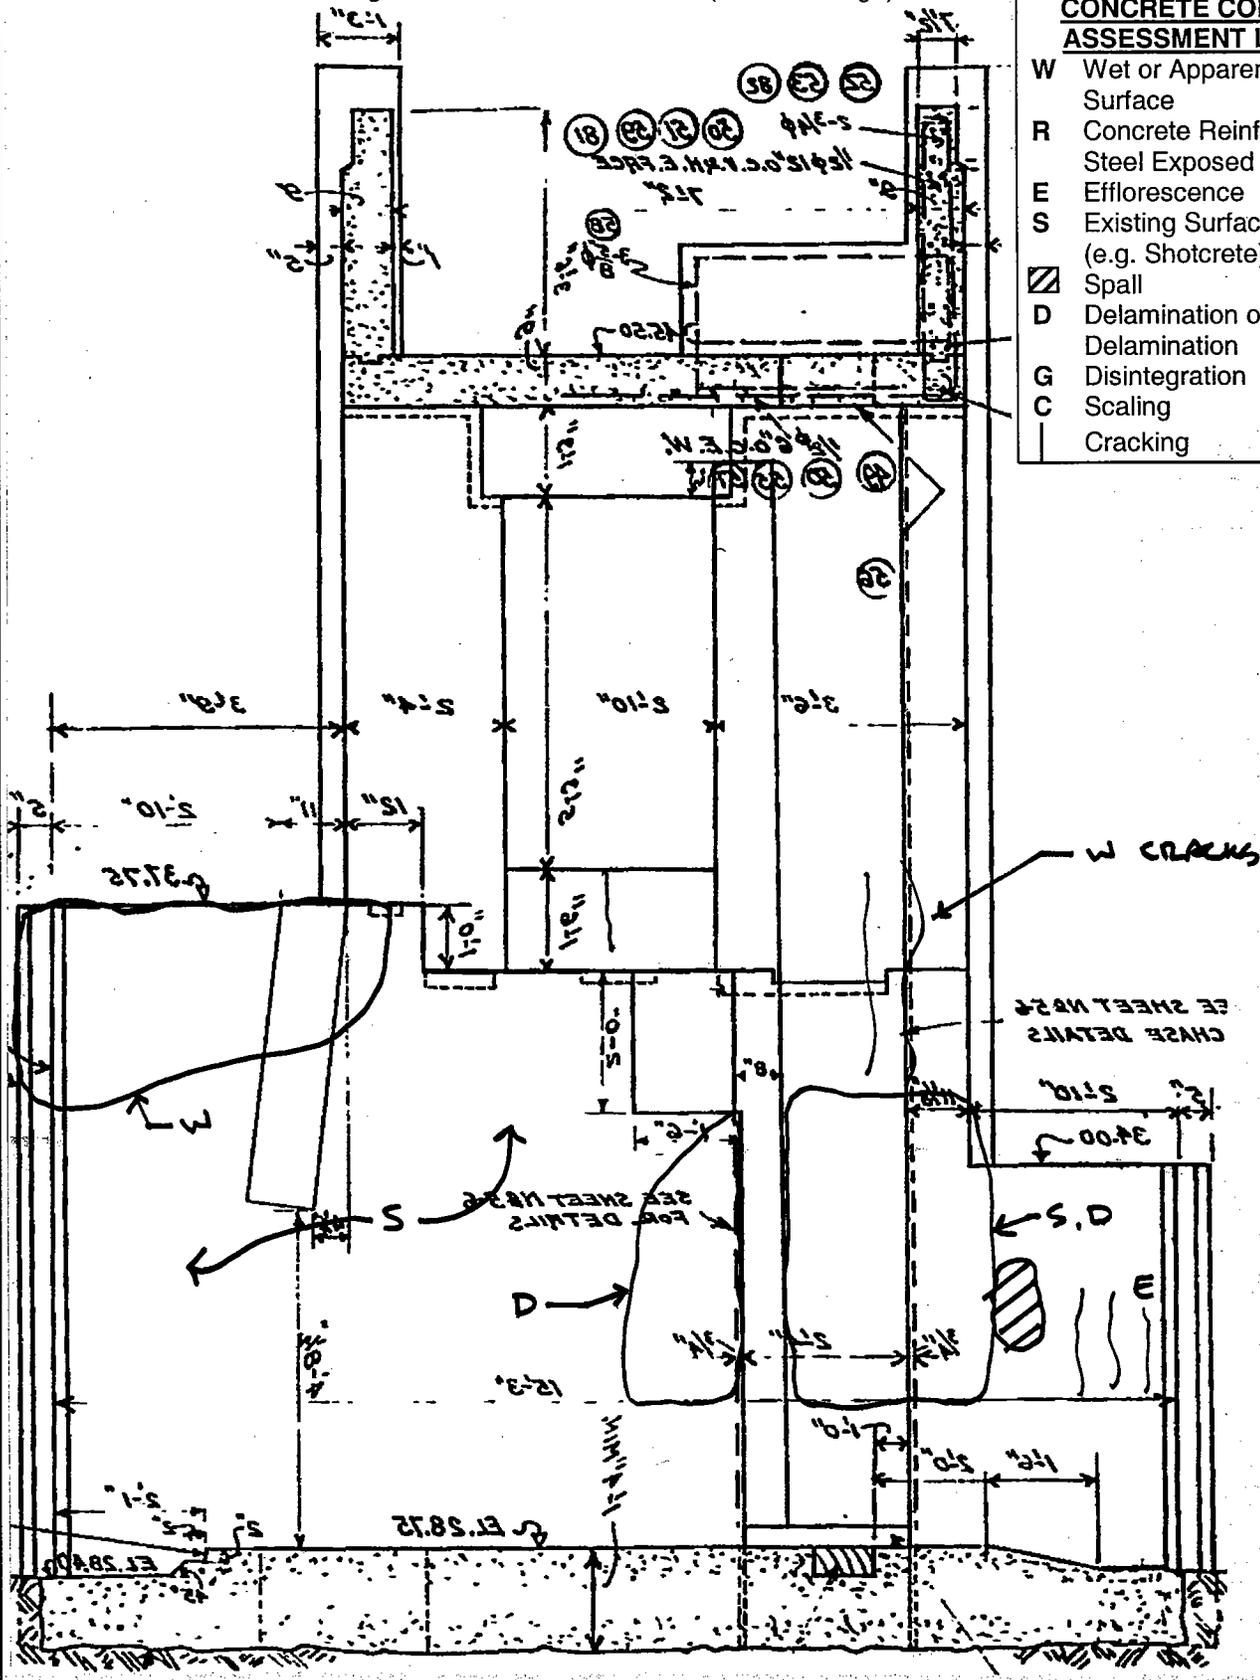
FIGURE 22

PROJECT <b>ESTABROOK PARK DAM, MILWAUKEE, WISCONSIN</b>		STS JOB NO. <b>X587996</b>	
SUBJECT <b>PIER 8 - RIGHT SIDE CONDITION OBSERVATIONS</b>		SHEET NO. <b>1</b> OF <b>1</b>	
ORIGINATED BY <b>JMK</b>	DATE <b>FEB. 3, 2006</b>	CHECKED BY	DATE

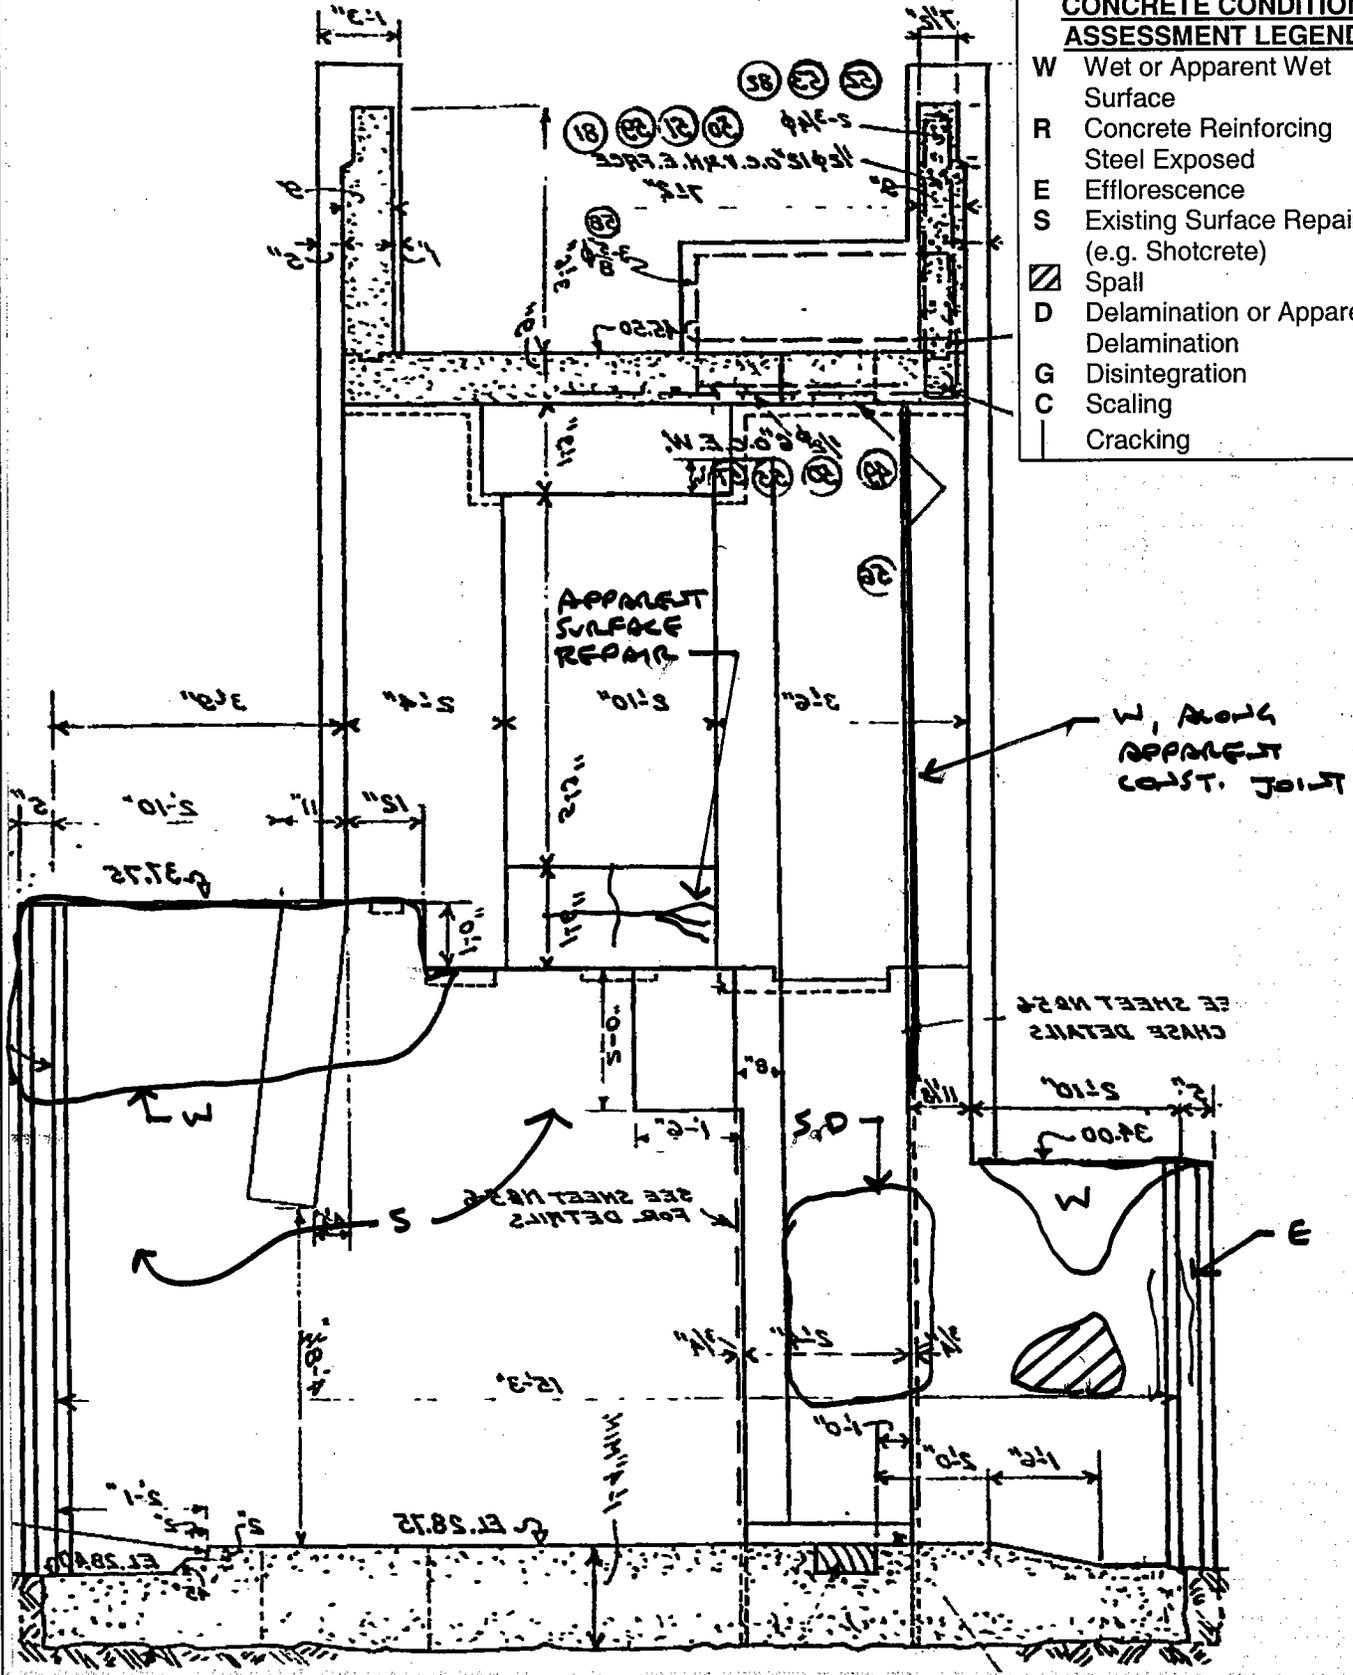
FIGURE 23

SUBJECT  
PIER 9 - RIGHT SIDE CONDITION OBSERVATIONS

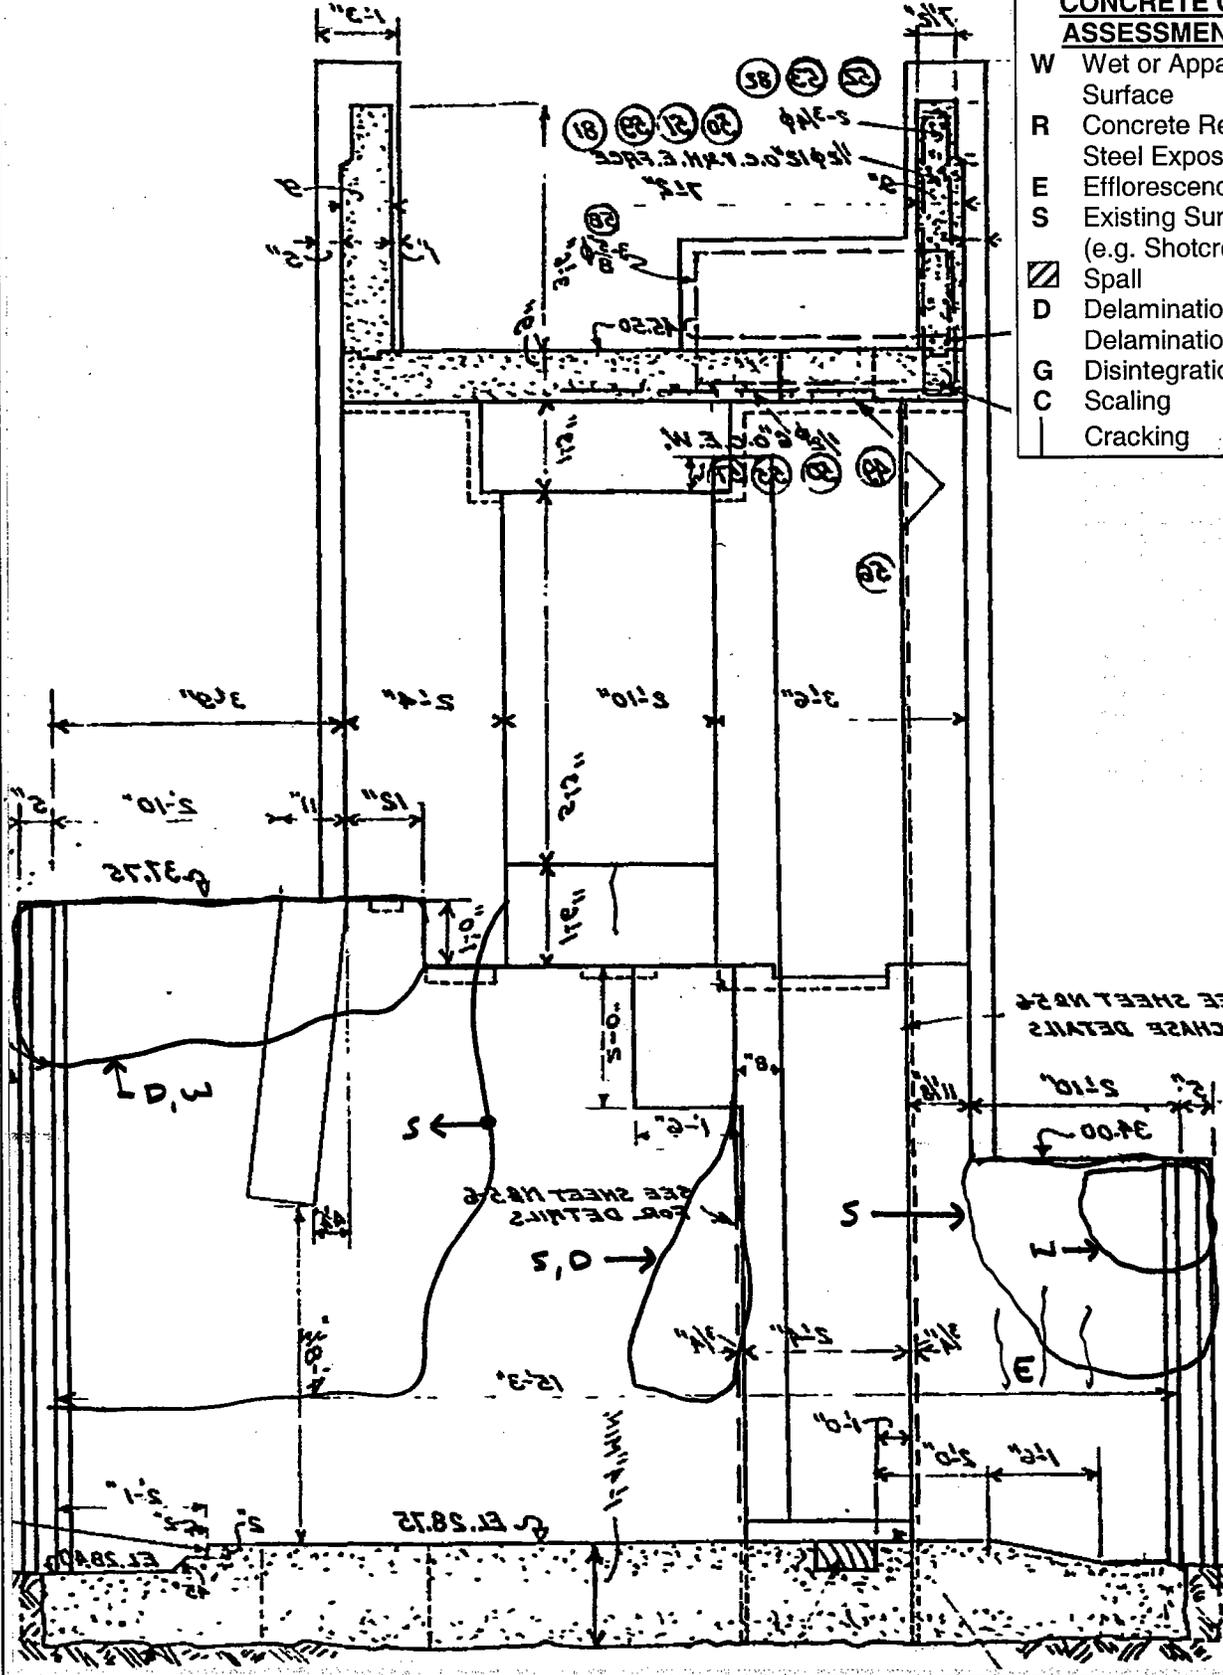
FIGURE 24

<b>STS Consultants Ltd.</b> CALCULATION SHEET	PROJECT <b>ESTABROOK PARK DAM, MILWAUKEE, WISCONSIN</b>		STS JOB NO. <b>X587996</b>		
	SUBJECT <b>PIER 10 – RIGHT SIDE CONDITION OBSERVATIONS</b>		SHEET NO. <b>1</b> OF <b>1</b>		
	ORIGINATED BY <b>JMK</b>	DATE <b>FEB. 3, 2006</b>	CHECKED BY	DATE	CALC. NO.

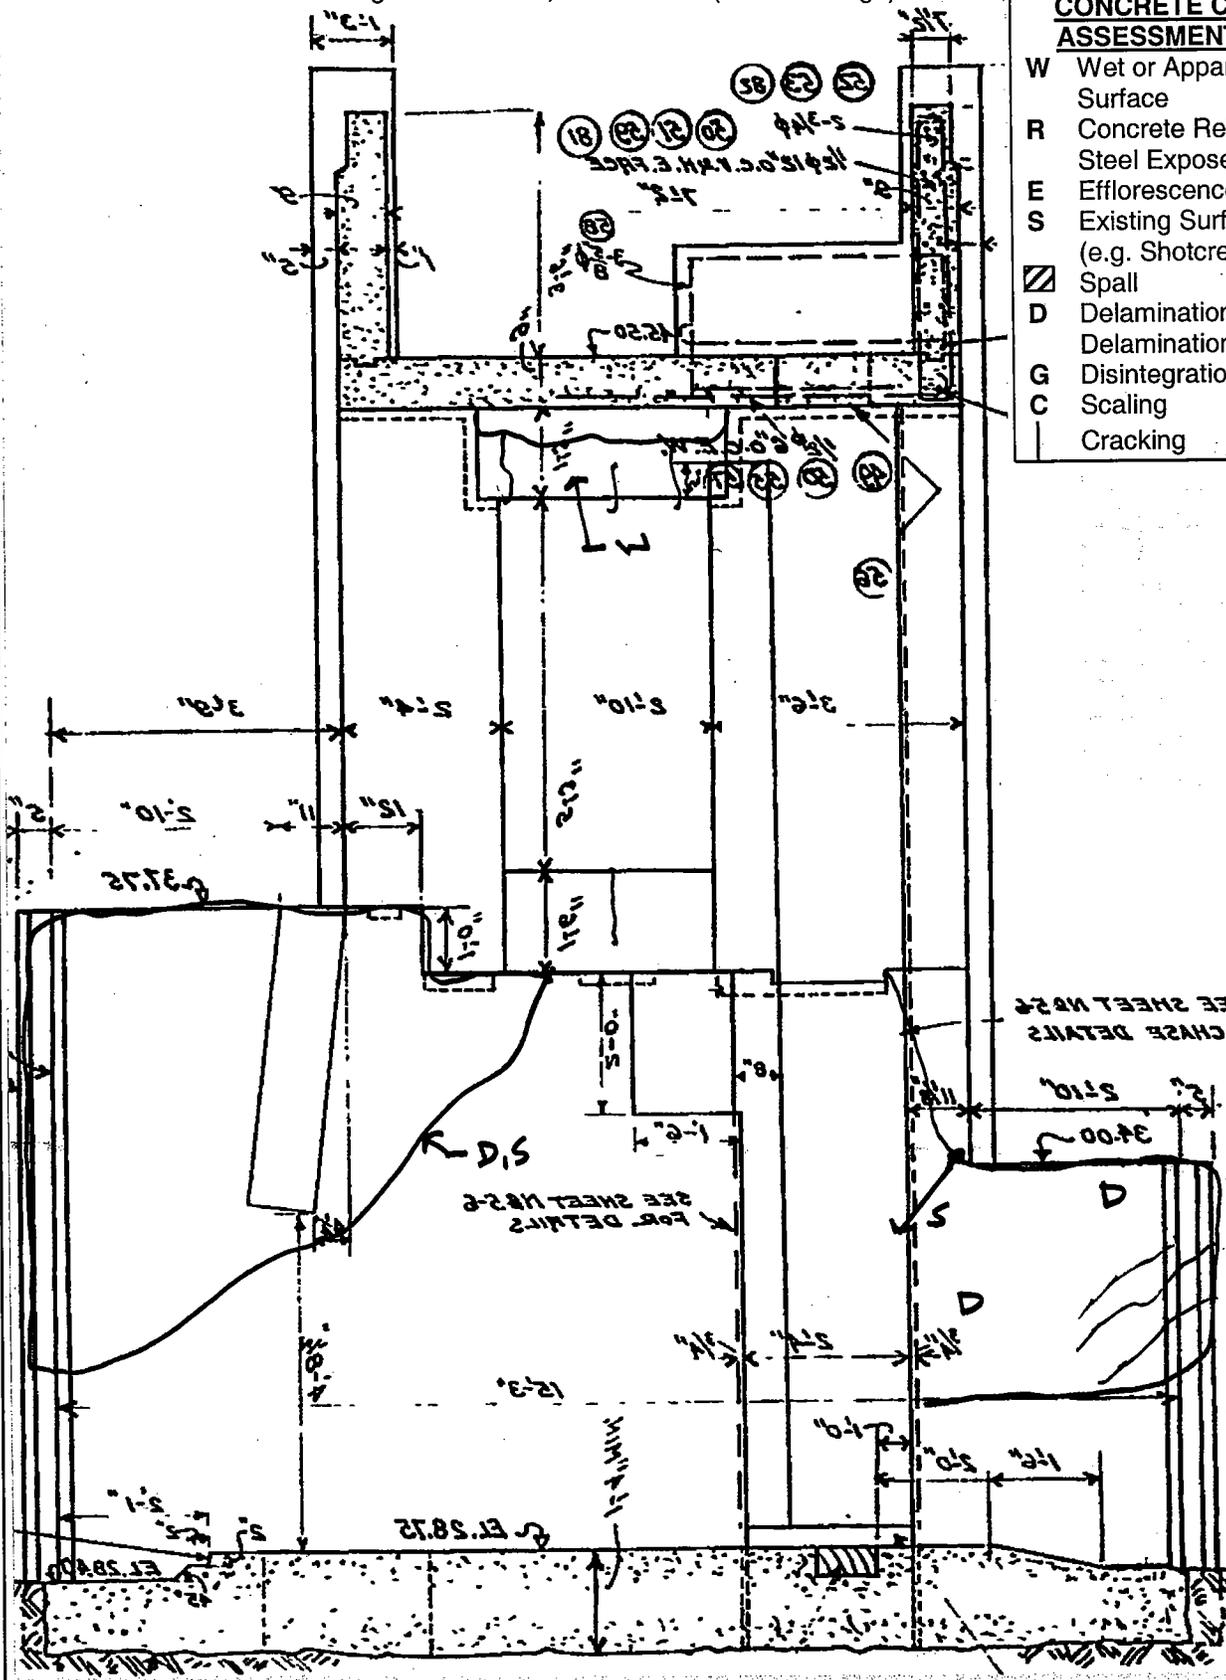
SUBJECT  
**PIER 11 - RIGHT SIDE CONDITION OBSERVATIONS**

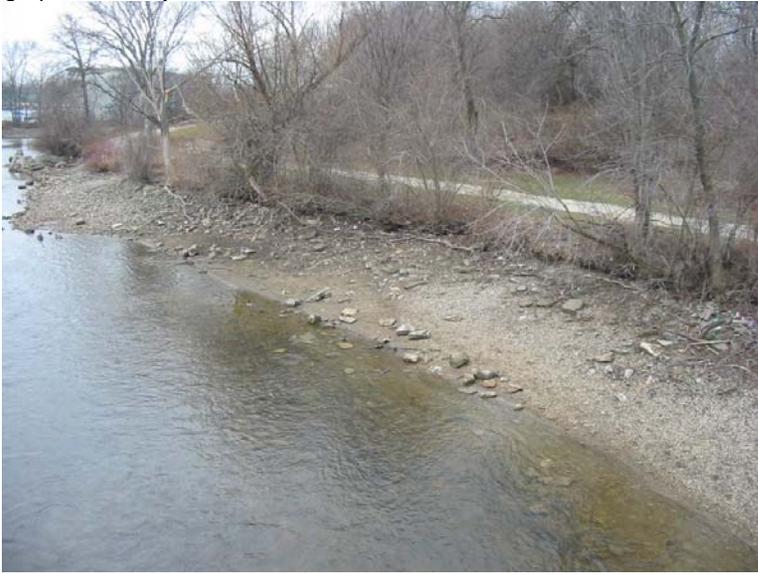
Photograph 13 – View of left bank upstream of gated spillway. Note minor undercutting of bank at max. pool level and lack of sufficient slope protection
